13 St Austin's Lane, Harwich, Essex.

13/14 St Austin's Lane, Harwich, Essex.
 TM 26024 32760
 List ref: 1298463

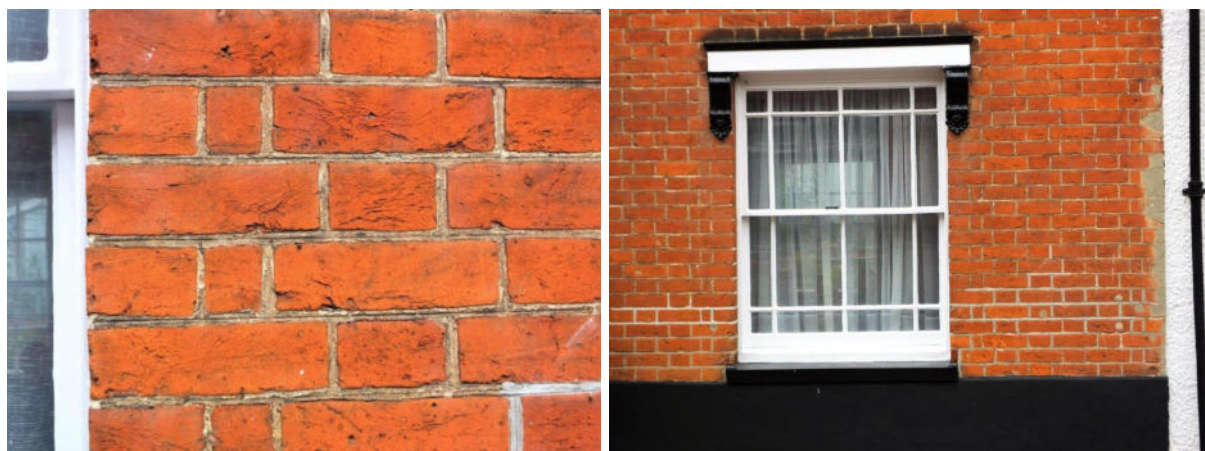
The front façade brick is good quality with inclusions suggesting in the region of 1830. It is finished with penny struck pointing.

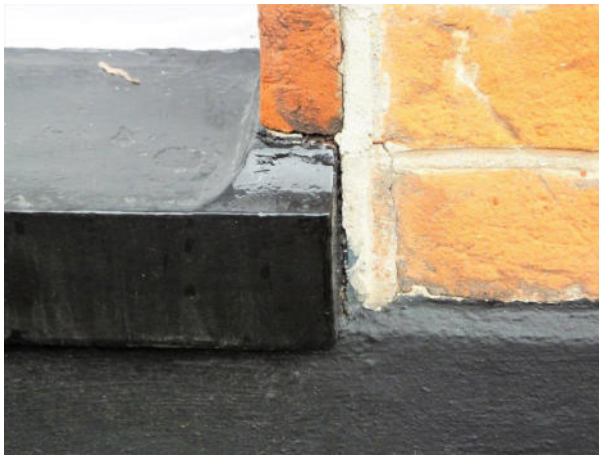
Cast iron window sill.

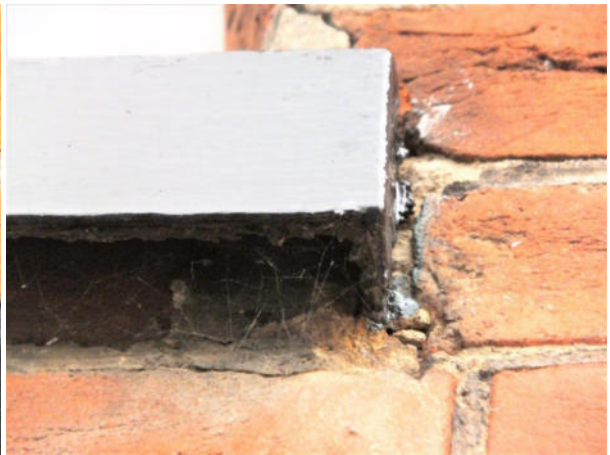
View up under sill to show hollow casting.

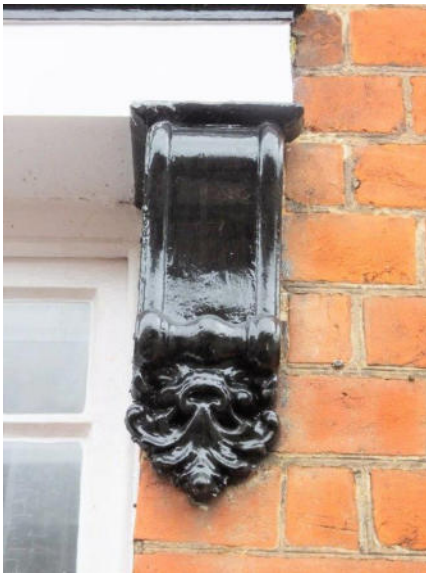
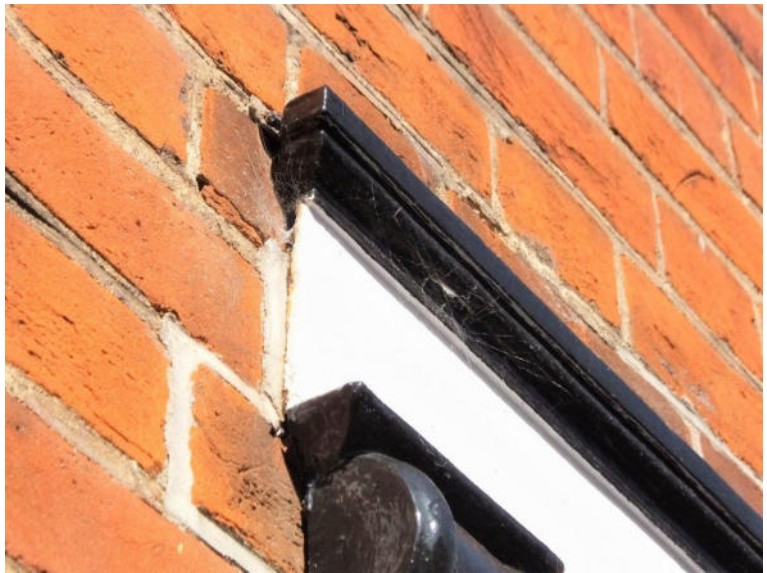
Console bracket in cast iron supporting a cast iron head to the window plate.

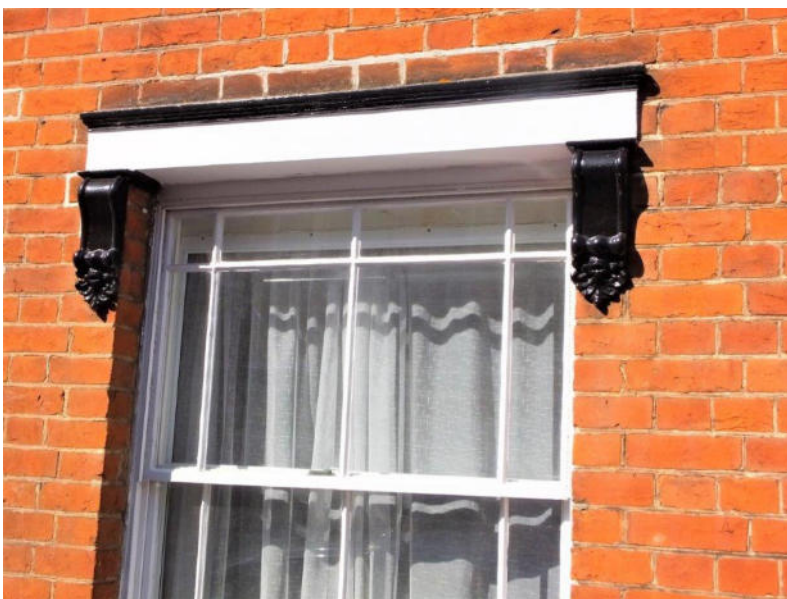
The cast iron head has a return under the brickwork to act as a lintel within the mortar thickness enabling the brickwork to be run as continuous courses.
