Samuel Pepys Restaurant, 31 Church Street, Harwich.

A 16th century timber-framed building of two phases aligned NW-SE with late 18th century brick front façade in Flemish bond.

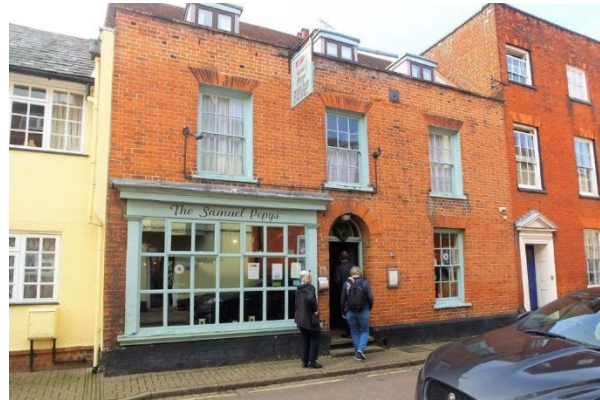
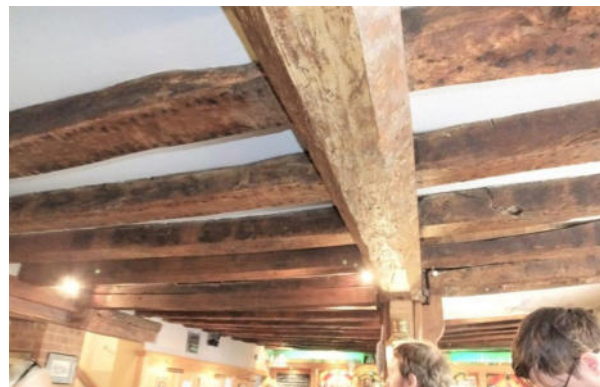
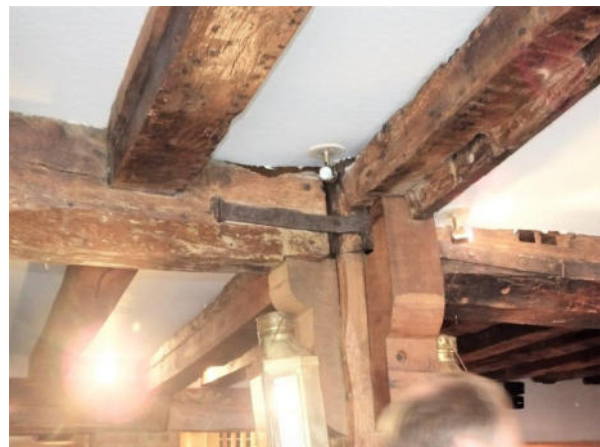
Side of parlour crosswing to hall with added support as complete side wall removed and the mid rail had been cut away most likely for a further change to anchor a screen or similar

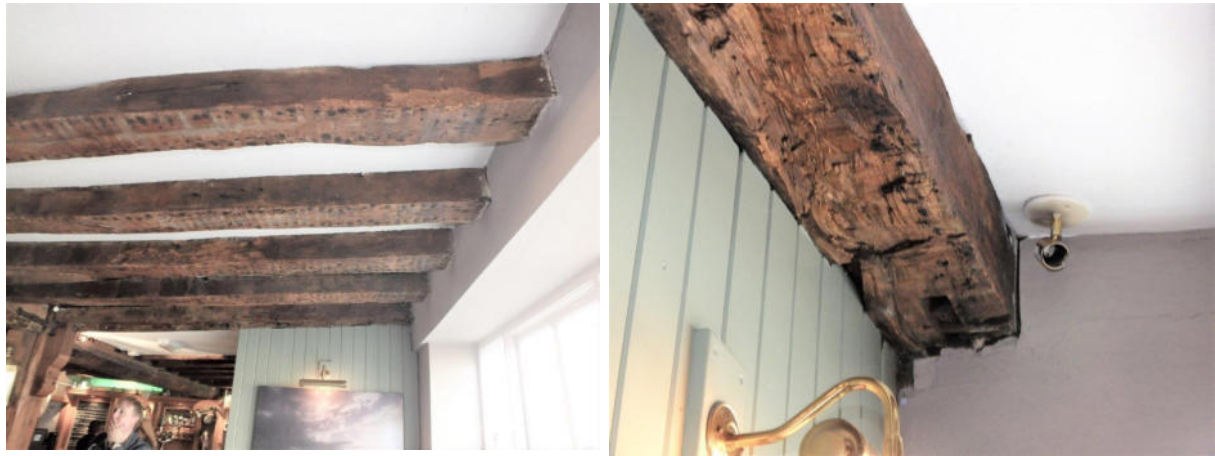
The former jetty to the ground floor has been under-built but the joists still have the pressure marks of the jetty plate and a dovetail for the jetty plate and mortise for jetty brace are visible in the NW mid rail of the parlour cross wing. A mortise in the mid rail of the SE parlour wall could be for a former stair trap but as joists adjacent have been replaced it is impossible to prove or disprove. The SE and NW walls are of close studded form with the gap in the studding of the NW wall against the rear storey post for a doorway. This is typical of the position for a door in the layout of a parlour cross wing. The transverse beam has a deep chamfer with run-out stops and the flat section joists are housed with soffit tenon diminished haunch joints. (This 16th century parlour cross wing could replace an earlier parlour and be part of an alternate rebuilding.)

Floor joists of cross wing to street. Jetty plate would have been above the light. Second picture shows remains of mortise for a jetty bracket and mainly destroyed dovetail housing for the jetty plate.
