The Crown Post, 57 Church Street, Harwich.

A timber-framed building built in the close studded tradition of the area and of 2 distinct phases. Aligned SW-NE it now comprises of a jettied rear range truncated to the front and rear that comprises of only one complete bay and a frontage building, jettied to the road and of 2 unequal bays with a 19th century frontage.

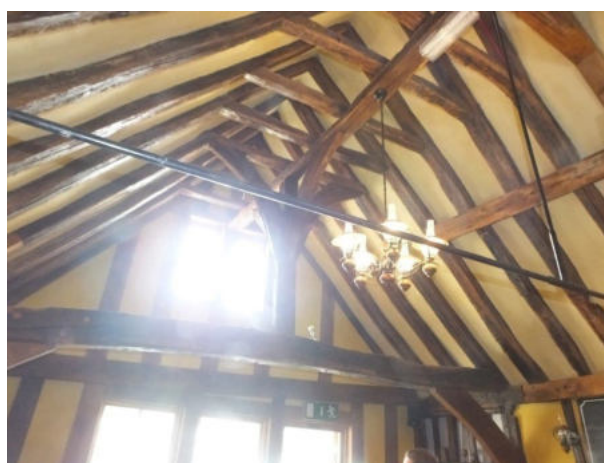
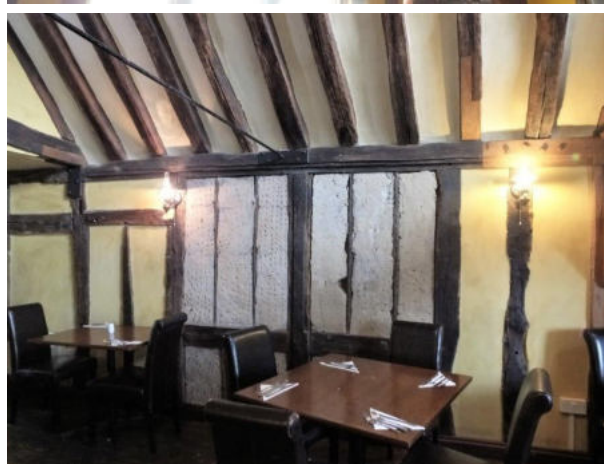
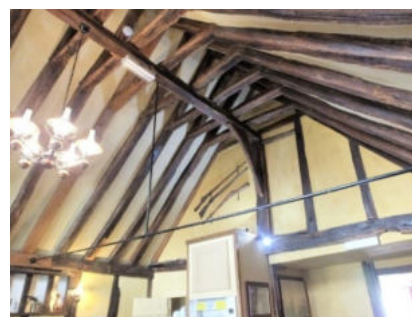
The tie beam of the rear open truss

is housed onto the wall plate above unjowled posts. The rear crown post is of cross quadrate form with four way bracing. The paired rafters have collars that sit on the collar purlin which continues to the front closed truss and supported by a brace to the central stud.

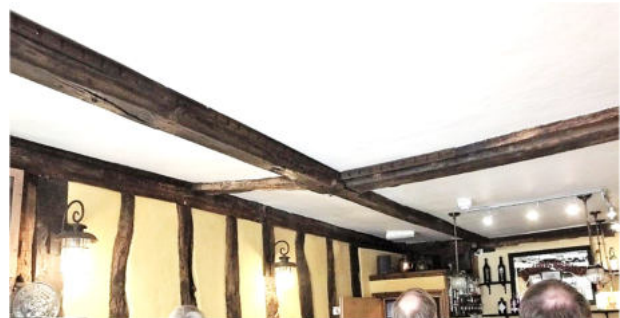
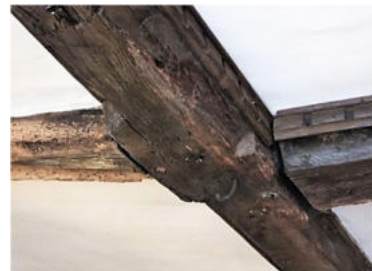
Window mortises at front and axial beam with crenellations

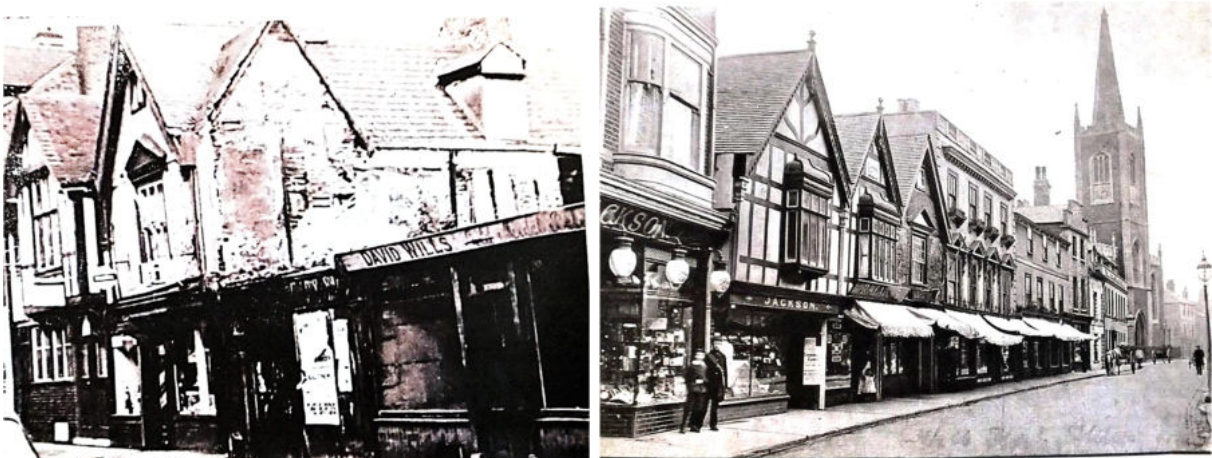
The Crown Post when the next property was demolished and the view from it along Church Street to the church.
