Further notes on 57 Church Street, (The Crown Post), Harwich.

Crown Post, 57 Church Street, Harwich, Essex.

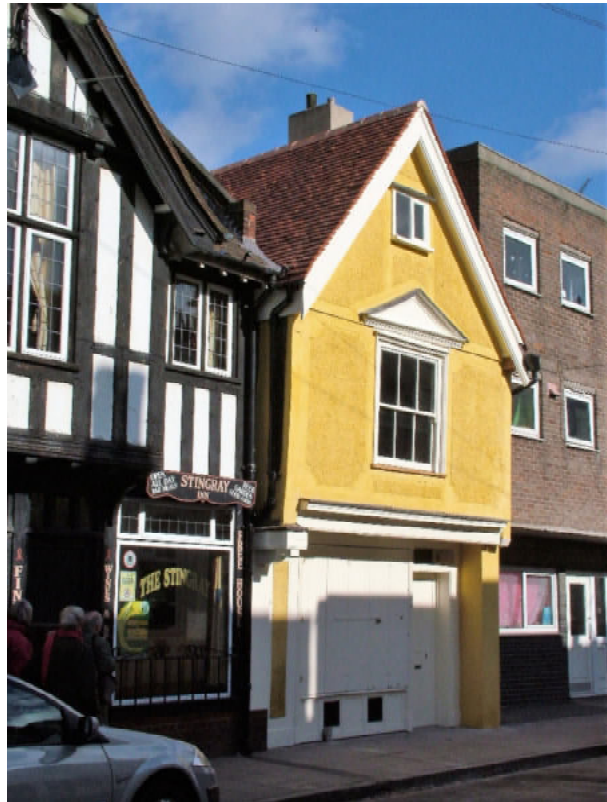
Frontage in 2007.

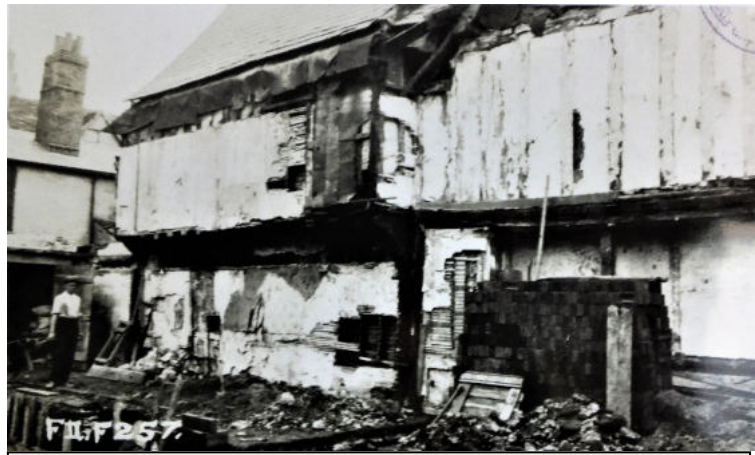
The front unit is of two bay parallelogram form and jettied to the west and north. A dragon beam, shown on the survey drawings appears to have been removed during restoration and the north side jetty underbuilt. The former construction helps to explain the now visible offset axial beam.

RCHME photograph taken in 1922 as the next door building was being demolished.

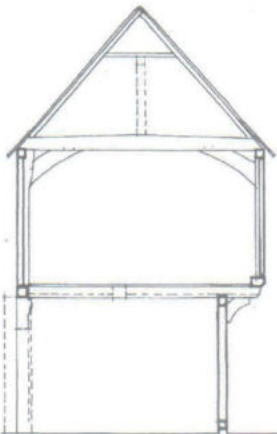
The roof is of crown post form with paired rafters, collars and collar purlin. The cross quadrate crown post is four-way braced to rafters and collar. The brace to the east is a replacement. On the survey drawings the collar purlin is shown truncated to the west and elements of the frame beyond are missing.

Section of rear range looking east.

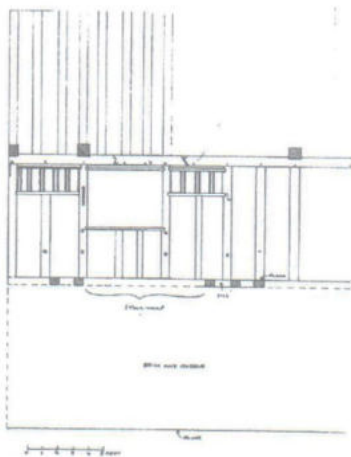
Later window changes in south wall of rear range

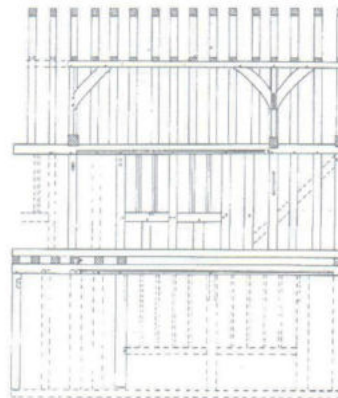
At first floor the windows are of more utilitarian form with diamond mullions. Paired windows in the north elevation light the main chamber and a single mullion window gives light to the stairs enclosed by a partition at first floor. A later alteration is the insertion of an oriel window flanked by frieze lights in the south elevation. As this would compromise the original fire hood/stack for the building to remain heated alternate arrangements must have been made. At some stage the paired windows in the north wall were blocked.

Earlier window in north wall of rear range blocked when new build to north
