## 5-6 Market Street, Harwich, Essex.

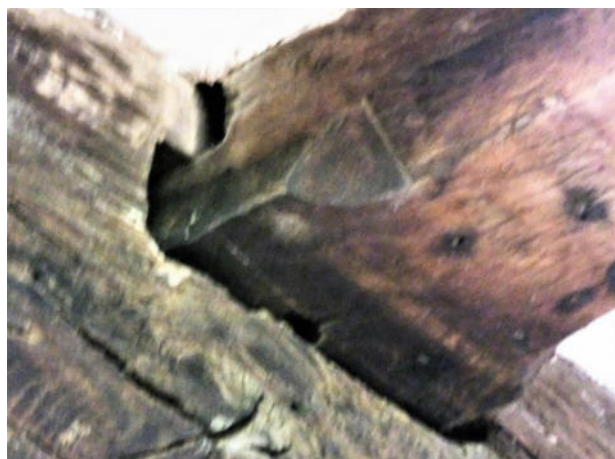
The NE bay is fully floored with chamfered axial beam and flat section chamfered

joists with run-out stops and housed with bare face soffit tenons. Additional trimmers against the central transverse beam and either side of the axial beam support the hearth of the later first floor fireplace. The NE wall is covered but peg holes in the soffit of the midrail imply an evenly spaced fully studded wall but it is impossible to confirm door openings or brace pattern.

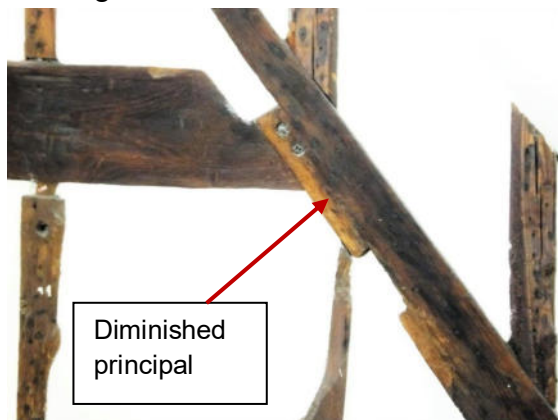
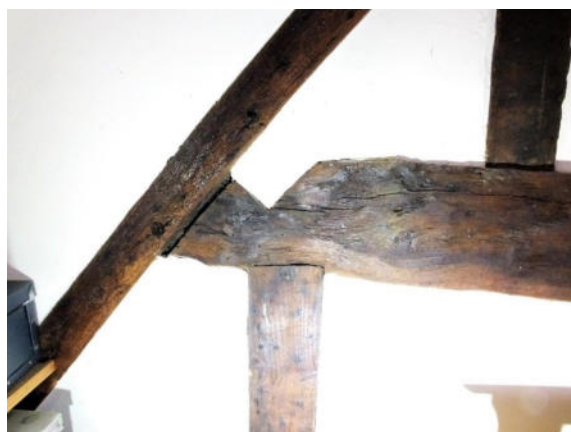
At first floor the NE wall is visible and consists of a jowled corner post, a flat tiebeam, typical close studding and trenched internal braces of Colchester style housed into the posts. The front corner post and part of the brace were lost when the later façade was added. The later roof raise has preserved the gable frame to both the NE and SW walls showing that the roof type was clasped purlin although these are missing. The NW truss has diminished

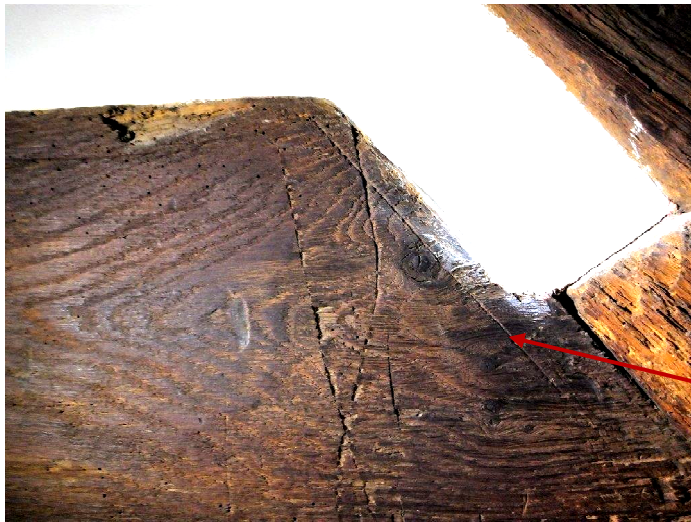
The lack of reduced principals also showed a variation in purlin size.

This illustration shows the scribing for a larger purlin section than had actually been used when the roof was constructed.

Scribed outline

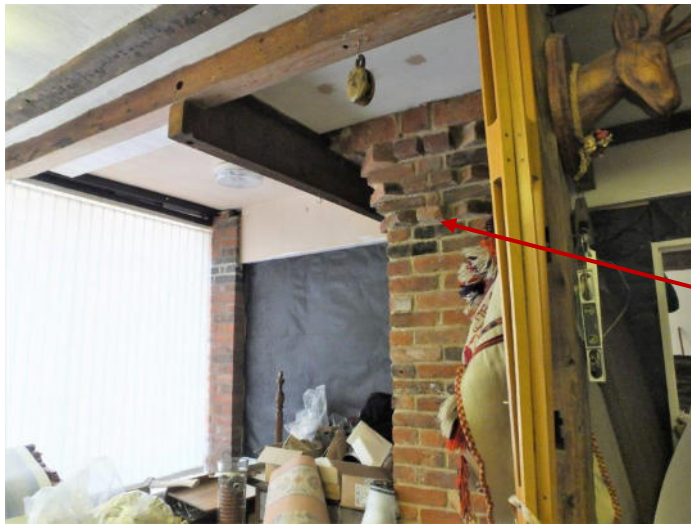
The upstairs fireplace now supported by a brick pillar on the ground floor.
