The Old Swan House, 14 King's Head Street, Harwich, Essex.

Introduction

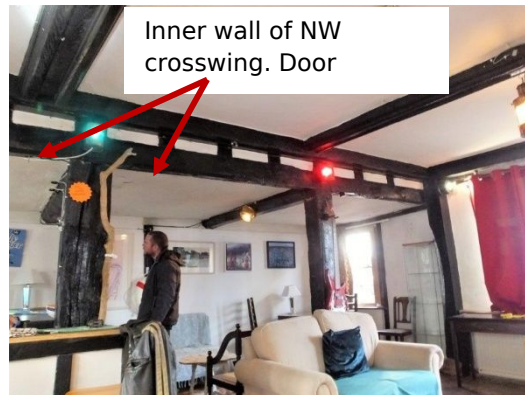
Inner wall of NW crosswing. Door

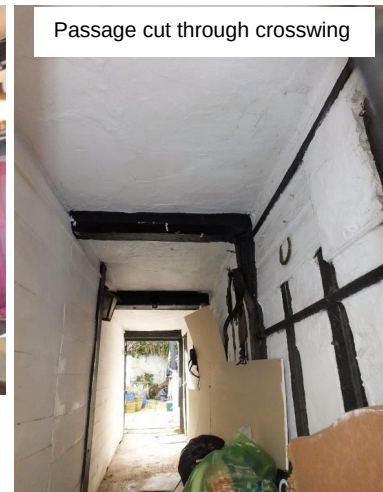
Passage cut through crosswing

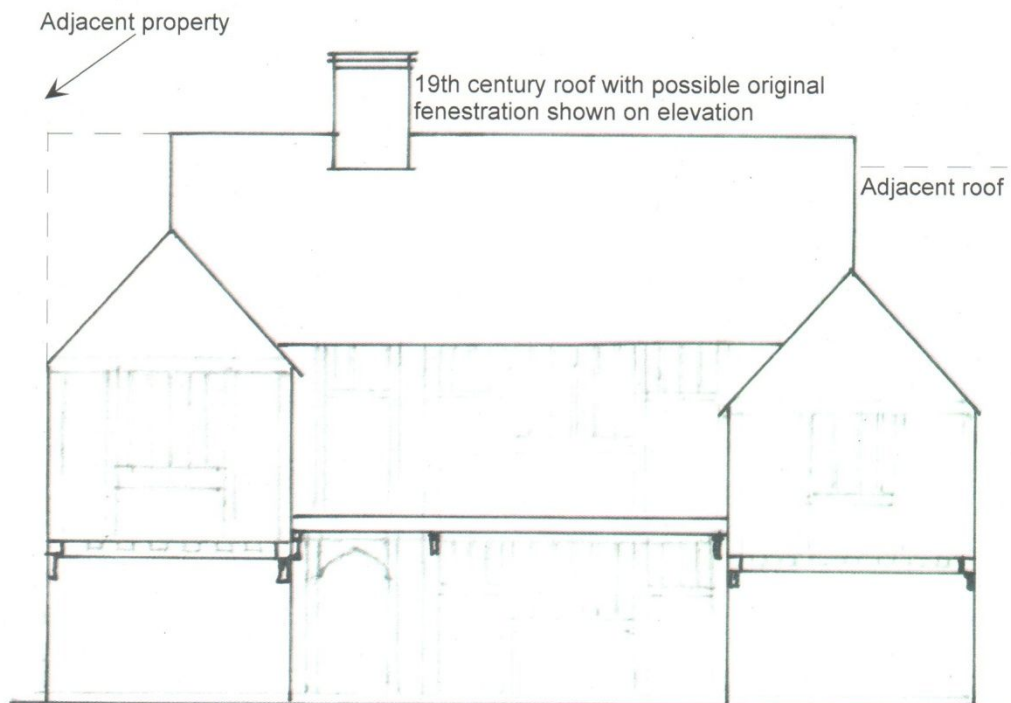
Possible 16th century elevation but ignoring the raised 19th century roof
