13 St Austin's Lane, Harwich, Essex

Painted Decoration

13, ST AUSTIN'S LANE,
Harwich, Essex

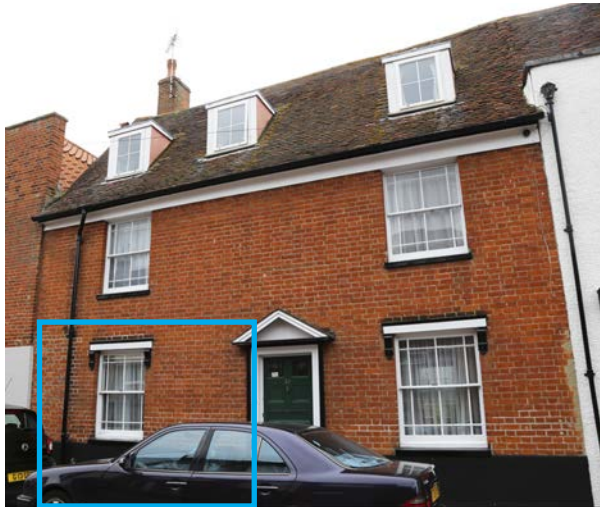
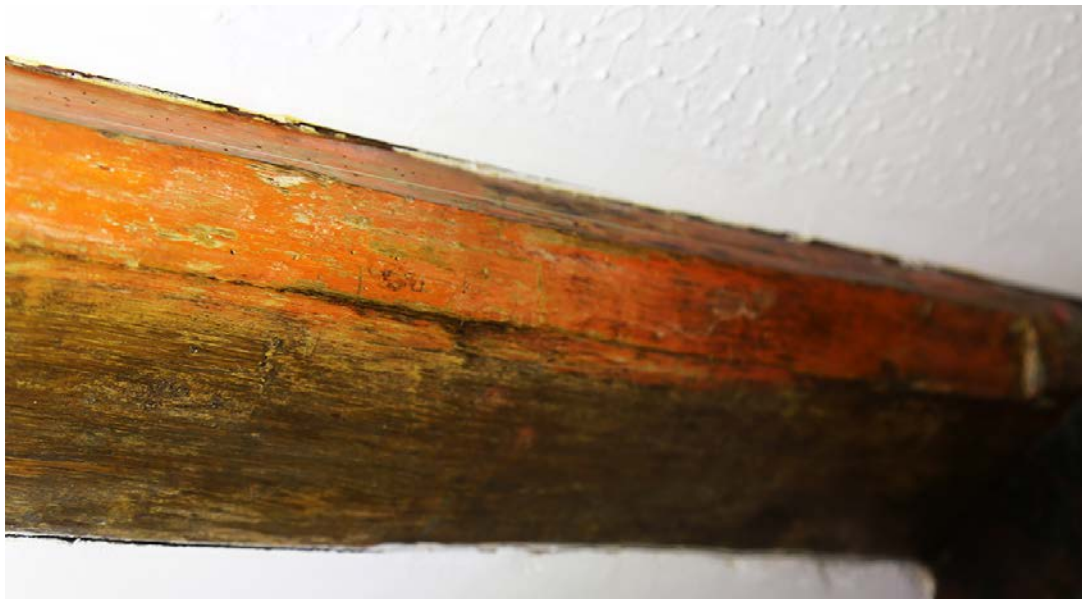
Red (red lead)

A layer of red lead was found in Samples 1, 2, 3, 4, 7 and 8 from the corbel, and in Samples 5, 6 and 9 from the rail. The red contains lumps of lead white, which is what one would expect in pigment made before the introduction of industrial furnaces.

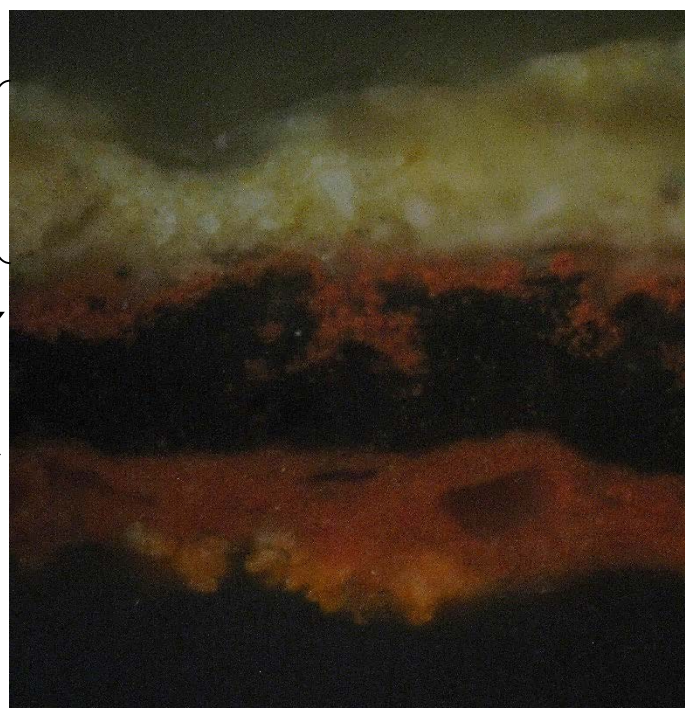
**SAMPLE 2**

Corbel

buff-coloured oil
paint based on lead white

two lots of red iron
oxide. Above and
below the black

no dirt visible between the
red lead and the first red
iron oxide

On top of the red lead in Samples 2, 4, 7 and 8 the cross-sections show a layer of pure red iron oxide of good quality, i.e. with small and regular particle size, an even colour and few inclusions [Sample 2, p.5]. It was not found in samples taken from the rail, but here the layers appear to have been more thoroughly scraped off, and it may simply have been lost.

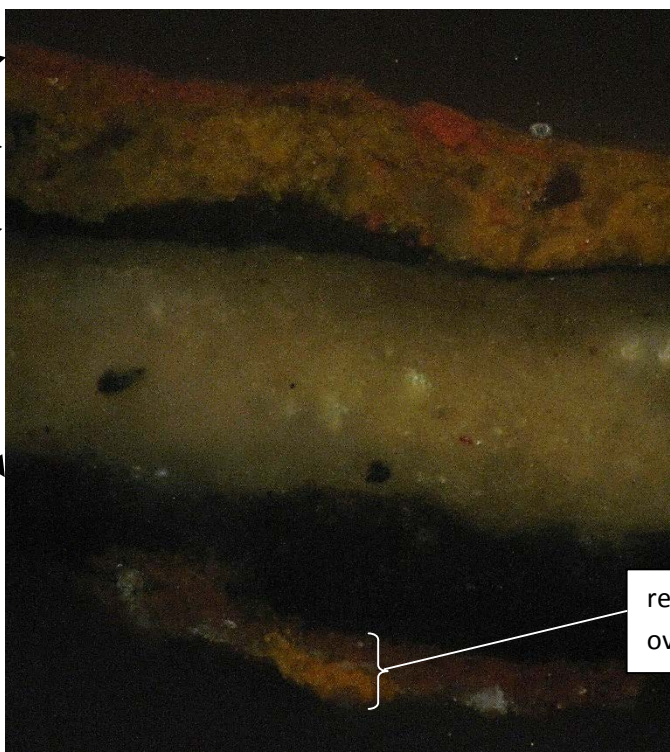
**SAMPLE 4**

Corbel

red iron oxide
yellow/brown iron oxide

The black is above and below
a layer of plaster

red iron oxide
over red lead

The black may have coincided with an episode of repairs or re-plastering because in Sample 4 [p.5] we can see the black followed by a layer of plaster followed by a second coat of black.

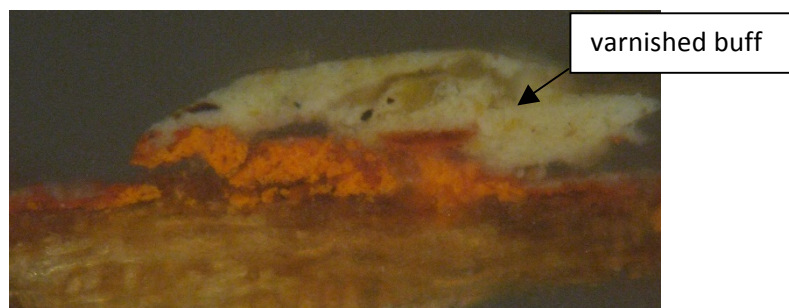
Fragment (ii)

wood and first layers

layers must have been scraped off
when the varnished buff was
applied.

- 6 Early paint layers must have been partly cleaned off at this point, because the sixth paint scheme in some fragments can be seen sitting on the scraped remains of the red lead [see Sample 7, p.6].

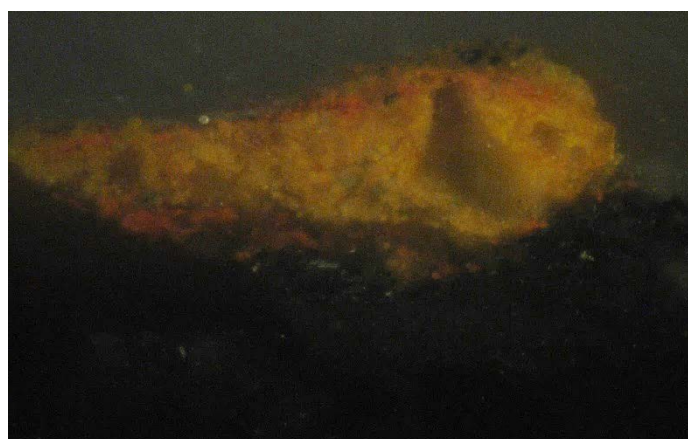
Detail of the yellow/brown

It may have had a darker
top coat

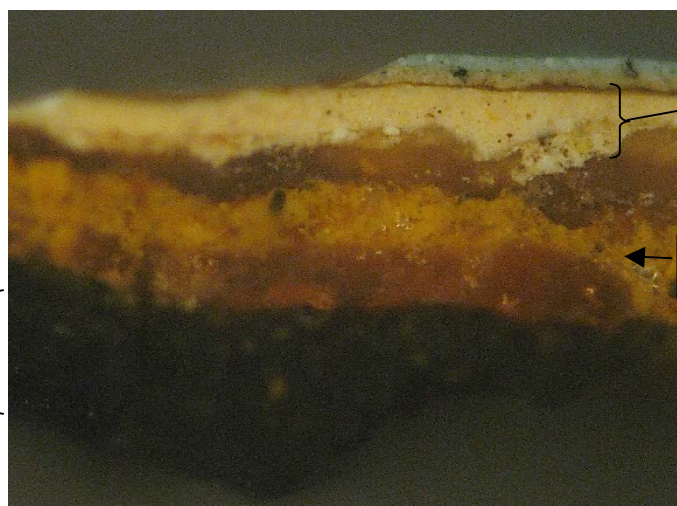
Fragment (i)

Ceiling beam – blue

The varnish laid over the buff scheme appears to have soaked down between earlier layers

black

varnished buff

yellow/brown

- 11-12 Two lots of blue over grey undercoats. The blue in both of these schemes was a mixture of Prussian blue and lead white. These were found in Samples 13 and 15 from the Ceiling Beam [see p.7].

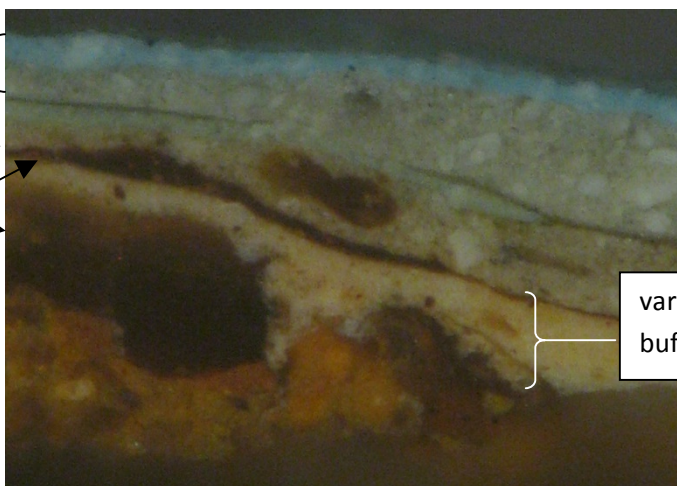
Fragment (ii)

showing two lot of blue over grey

light brown varnish has worked its way down

varnished buff

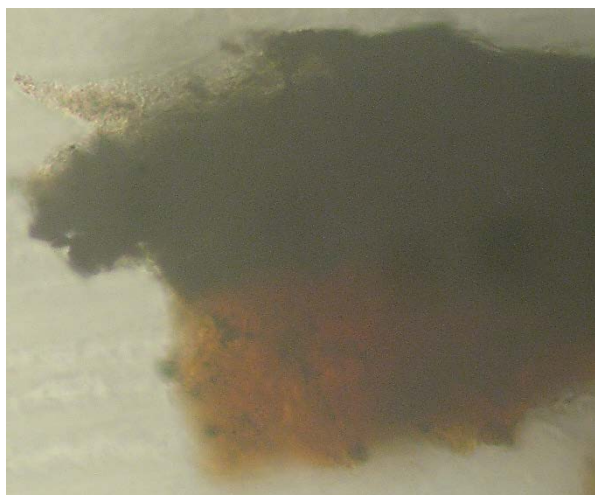
Left end of section, lit from behind to show the varnish

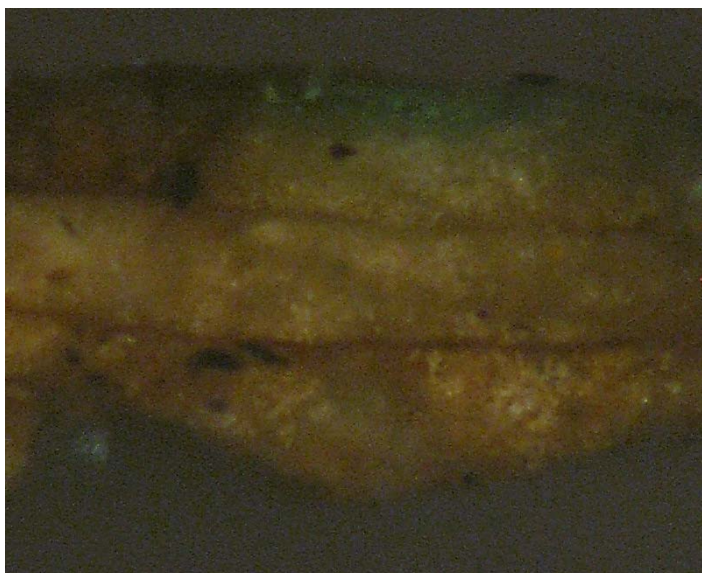
**SAMPLE 16**

Chimney lintel – green

layers of white distemper, or limewash, with green on the top

It is not clear if the green in Sample 16 [p.8] pre-dates or post-dates the yellow/brown. The green in Sample 16 is over at least three lots of limewash [or distemper]. The pigment is verditer, and as it was mixed with chalk it was probably a type of distemper.

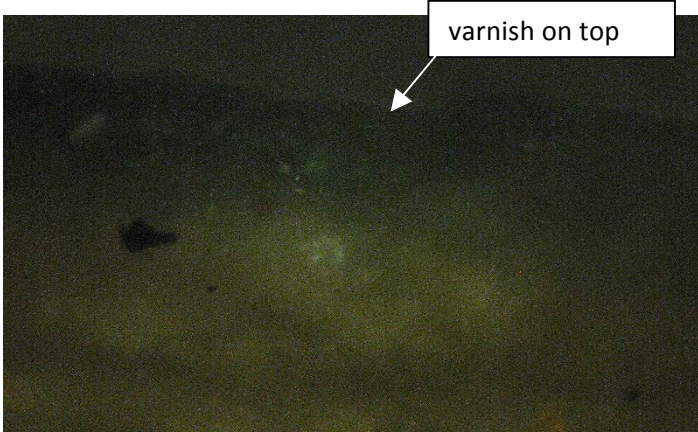
Detail of the green

The layer is chalk and verditer

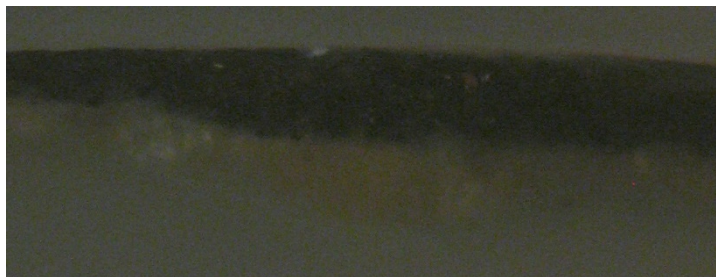
SAMPLE 17

Chimney lintel

No green visible over the black.
White limewash under the black

The limewashes were followed by a varnish layer and then a black scheme [Sample 19, p.9]. In some fragments, such as Sample 17 [p.9], there is a very thin white limewash layer under the black.

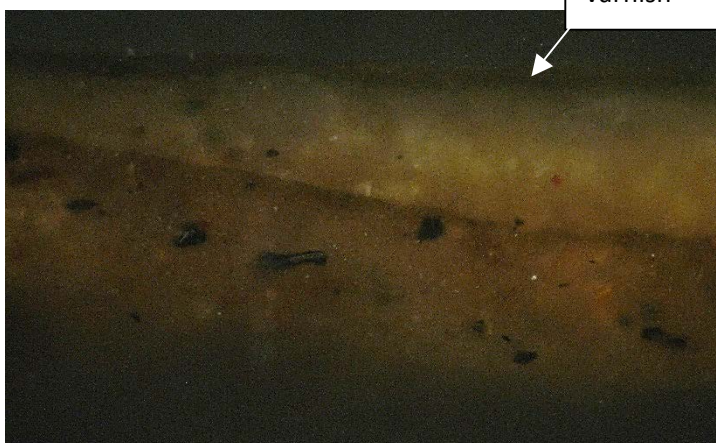
**SAMPLE 18**

Chimney lintel

Two lots of limewash

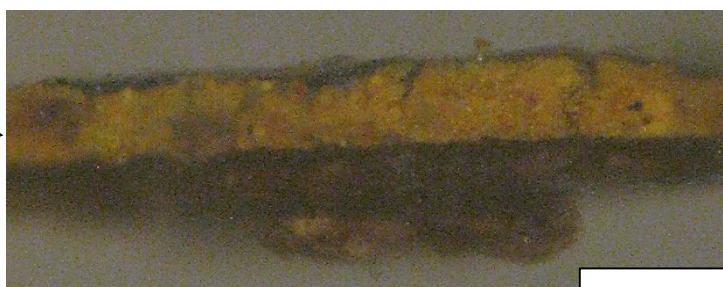
**SAMPLE 19**

Chimney lintel – brown on black

yellow/brown →

A coat of clear varnish has been applied at some point. It was found in all samples, but can be seen most clearly in Sample 19 [p.9].

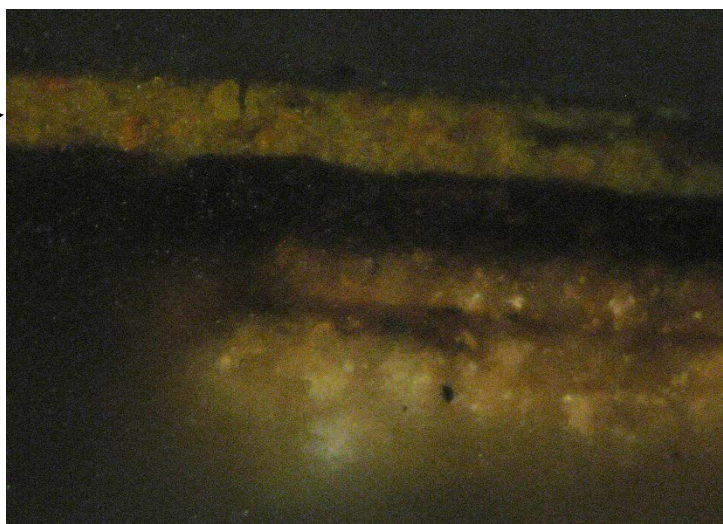
SAMPLE 20

Chimney lintel – brown on black

yellow/brown →
black →
earlier limewashes {

On top of the black in Samples 19 and 20 is the dull yellow/brown used throughout the room. Used on the corbel in Samples 3 & 4, and in all samples from the beam apart from Sample 10.

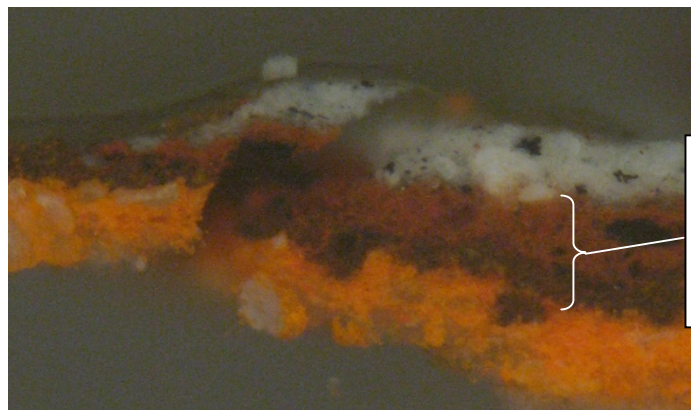
Fragment (i)

SAMPLE 22

Dining Room ceiling beam.

red/brown
over dark
brown
undercoat

A coat of dark red/brown paint was applied over the red lead. It was laid on in two layers with an umber undercoat and a red/brown iron oxide top coat. The layers can be most clearly seen in Sample 22 [p.11].

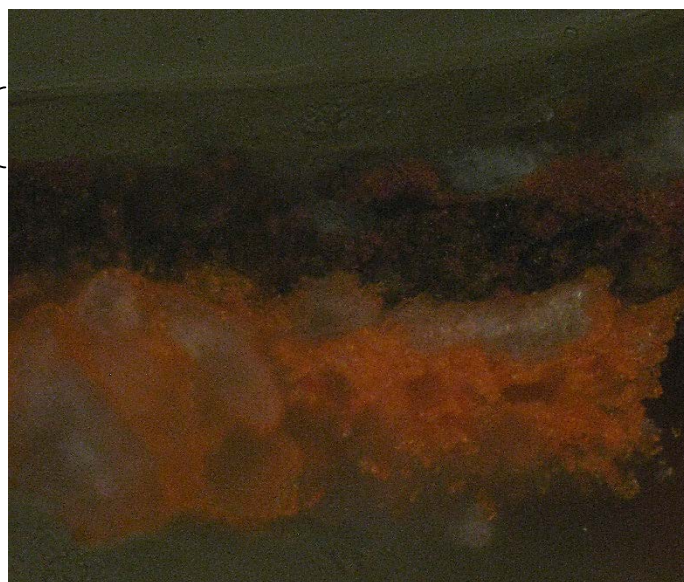
Detail of the left end of the section

2 lots of clear varnish {

Two coats of clear varnish have been applied at some point to the beam.

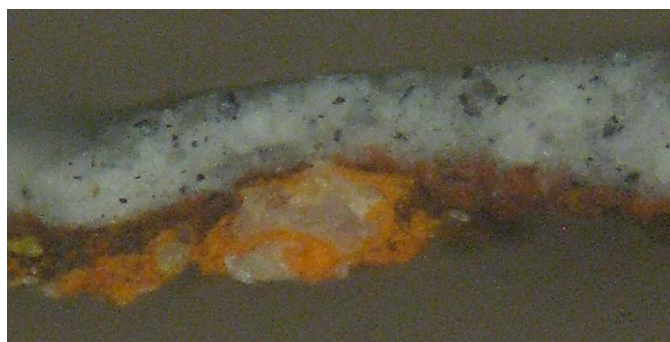
**SAMPLE 23**

Dining Room ceiling beam

A coat of red lead, which looks the same as the red lead used in the Living Room was found in all three samples. In Sample 23 [p.11] the cross-section shows it sitting on clean wood, but in Sample 21 [p.10] it is over a thin coat of fine white plaster or white limewash.

In Samples 22 and 23, the red/brown was followed by a light grey oil paint mixed from lead white and carbon black. The pigments are hand-ground, so this is no later than the early nineteenth century.
