**AN ARCHAEOLOGICAL
INTERPRETATIVE SURVEY
OF
24, 25 (THE ALMA), 26, KING'S HEAD ST.,
HARWICH, ESSEX**

**by
David Martin FSA IHBC and Barbara Martin**

2019

**24, 25 (THE ALMA), 26, KING'S HEAD STREET,
HARWICH, ESSEX
NGR TM 25962 32772**

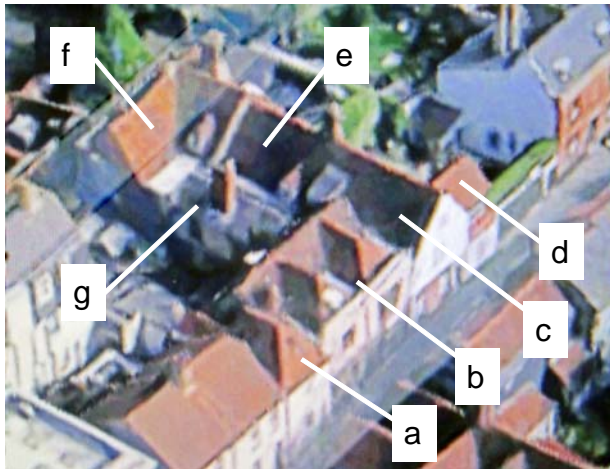
Plate 1

Exterior from west (image Google Earth)

- a) North crosswing (Period B — No 24)*
- b) Main range (Period D1 - The Alma, No 25)*
- c) South crosswing (Period C — No 26)*
- d) South 'porch' (Period D2 — No 26)*
- e) Eighteenth century link range*
- f) Eighteenth-century range (No 9 East Gate)*
- g) Addition at side of link*

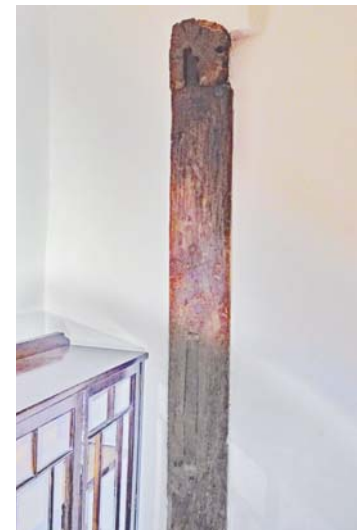
Plate 3
Principal post C in north wall showing cut-off tiebeam and mortice for former arch brace

The frame is of traditional construction with the tiebeams carried in normal assembly over the wallplates and principal posts (visible at post C in the north wall — Plate 3). Post C has a very slight swelling jowl. All timbers are neatly finished, but of small scantling: ie principal posts 180-190mm wide

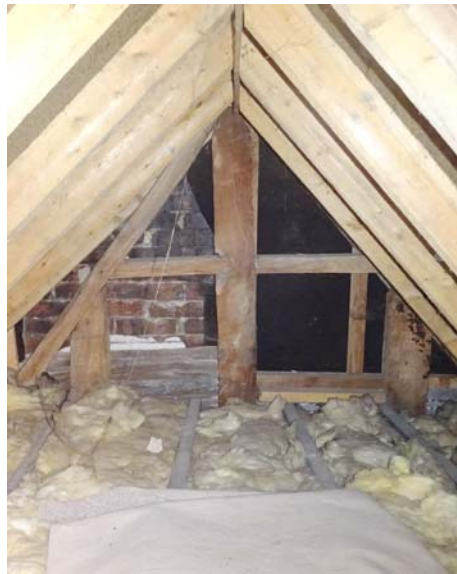
Plate 5
 Fragment of rear (east) roof gable of north crosswing visible in gable of modern roof

and in Drawing 3, 'South Wall of North Crosswing'. Housed across the external face of the studs in the south wall is a slightly curved footbrace (Plate 4) and there is a pegged mortice for a similar brace against the south face of jetty post A in the front wall (Plate 6). In the eastern roof gable a collar is housed past the internal (western) face of the studs (Plate 5).

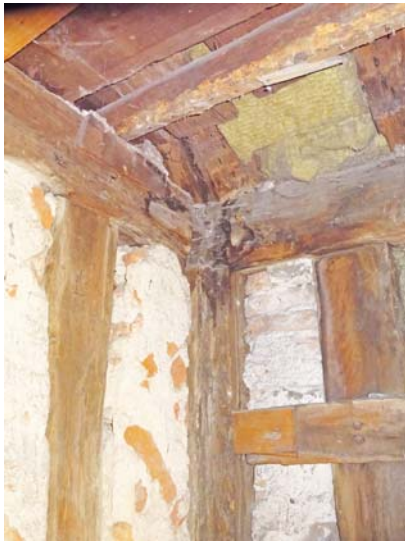
Plate 8
Front wall (left) and side wall
(right) showing level assembly

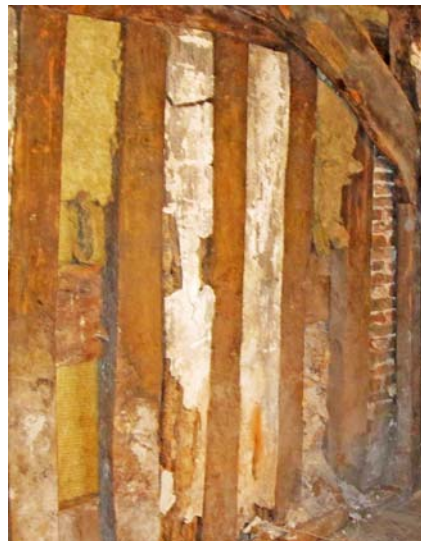
Plate 9
North face of crosswing's north
wall viewed from hall chamber

Archbrace of truss K-K as existing in 2019 [for earlier appearance see Plate 9 on page 14] with, on the right, close studding within the front wall with associated clerestory window above.

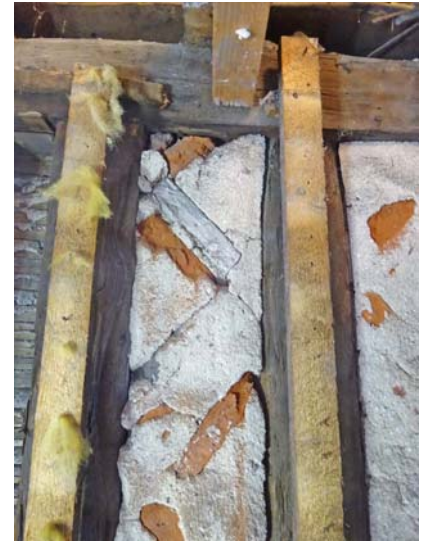
Plate 10
Brick infill to front wall,
first-floor level

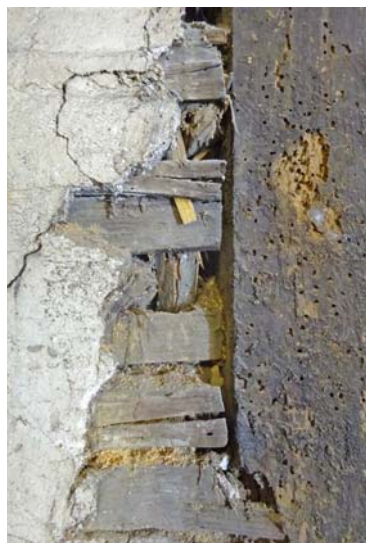
Plate 11
Daub infill on ground floor
of north wall, viewed
internally

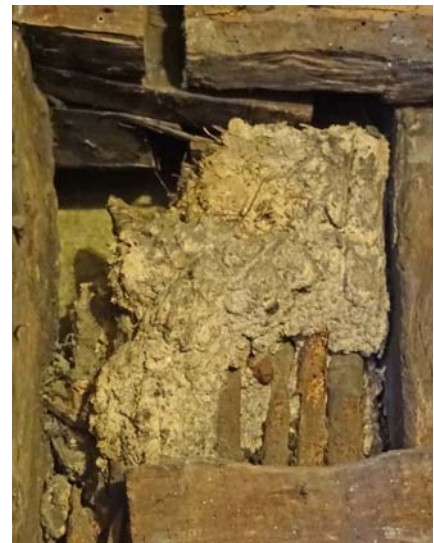
Plate 12
Daub infill on first floor
of north wall, viewed
internally

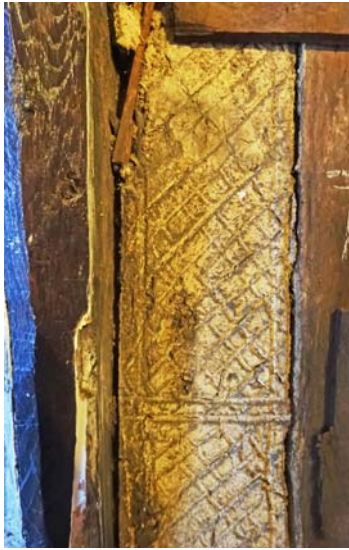
Plate 13
 Incised pattern on face of
 first-floor panel, north wall
 viewed internally

be significant that it varies from the Sussex panels in that the pattern has been inscribed with a single-pronged comb, rather than one of four or five prongs.

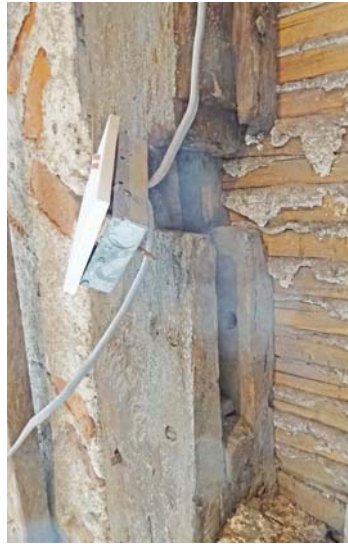
Plate 14
 Mortices for cill of former
 first-floor oriel in front wall
 of crosswing

Two period-C window positions are evidenced in the crosswing; both are on the first floor of the front bay (E-F). That in the front wall was located centrally and measured 1.70 metres by 1.15 metres (5ft 7ins x 3ft 9ins) internally. It was an oriel window and peg-holes in the side jambs located 550mm (1ft 10ins) down from the soffit of the 'tiebeam' indicate that it incorporated a transom in each side light (and, therefore, across the front face also). The form of the oriel's head is not known, but square-shouldered

mortices indicate the cill was of solid type with the fully projecting part measuring 130mm deep. Furthermore, below its shouldered element the mortice extends down for a further 250mm (Plate 14), indicating the overall depth of the cill was 380mm and that externally it would have incorporated an integral corbel (for an example of similar type see Plate 15).

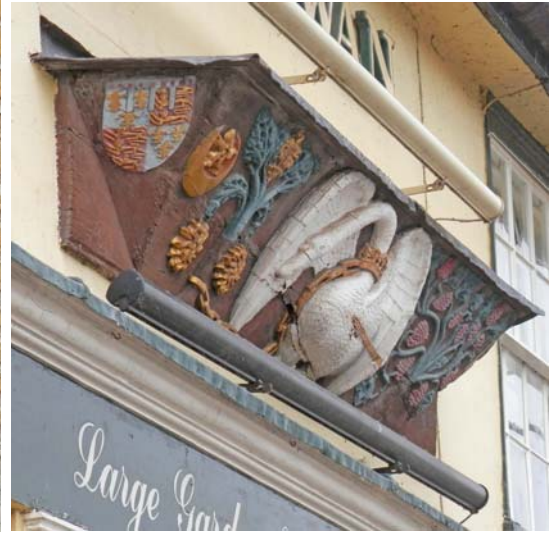
Plate 15
 Cill of an oriel in Clare, Suffolk, similar
 to that which formerly existed in the
 front wall of the crosswing

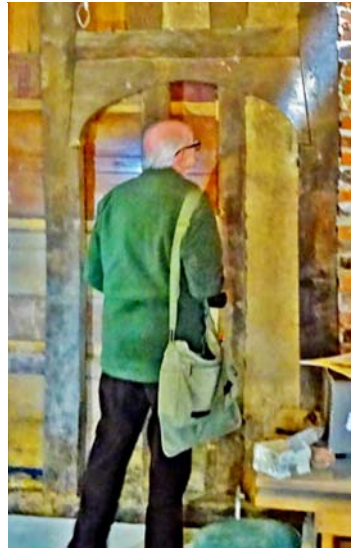
Plate 16
Internal (south) face of
doorway from hall into
ground-floor room

Access to the ground floor of the crosswing from the period-A/B hall was by the 1.00 metre (3ft 3ins) wide doorway shown in Plate 16. As can be seen, it has a four-centred — almost semi-elliptical — arched head which has haunched joints to the jambs, all set immediately below a square head. As noted earlier, there are no indications of the opening having ever been closed by a door, but there could have been a hanging curtain. On the hall face the spandrels of the arch are entirely plain, whilst the leading edges of the jambs and arch are simply chamfered.

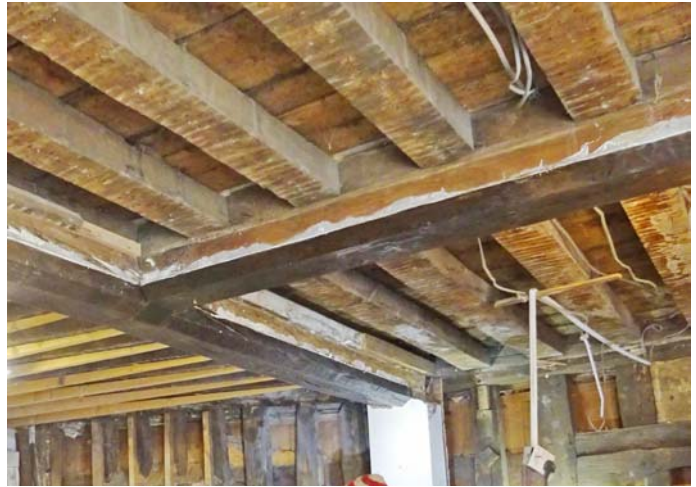
Plate 18
Joists viewed from the south with bay E-F on the left and bay F-G on the right

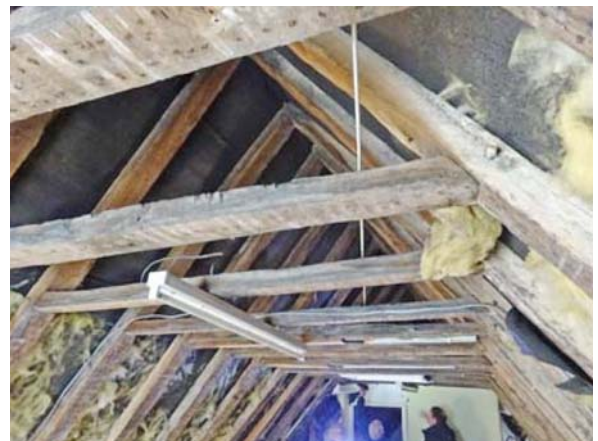
Plate 19
Interior of roof looking east towards the rear gable

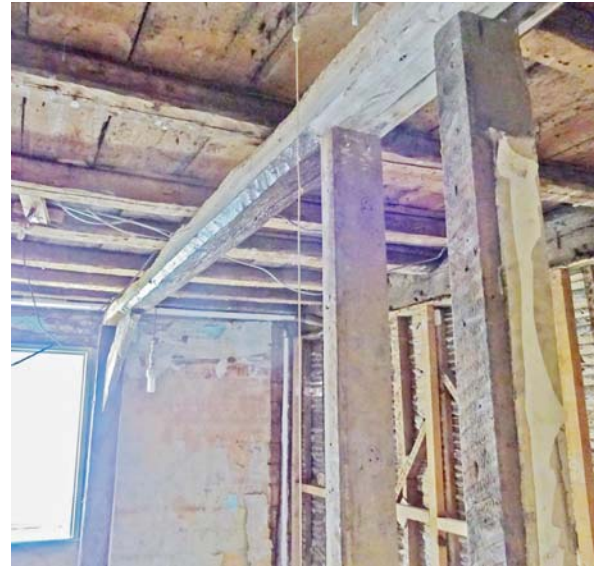
Plate 20
Refixed headbraced crownpost (against far wall) and associated collar-purlin

associated headbrace have been reused in 'modern' times to serve as a strengthener to the inserted joists of the post-medieval attic floor (Plate 20). A further section of collar purlin has been reused as a stud within an inserted first-floor partition. The crownpost is plain, measures 165mm across by 120mm in its original east-west direction, and supports a curved headbrace of 50mm by 215mm section, rising to the collar purlin. Further along the collar-purlin are the mortices for the former crownpost to open truss F-F and its associated headbraces. The lower leading edges of the collar purlin are neatly chamfered and have simple run-out stops at the crownposts.

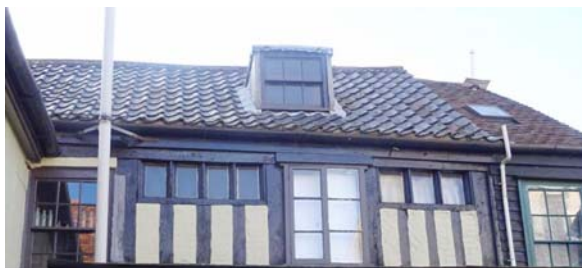
Plate 23

Rear wall of bay H-J showing fenestration

Nothing is visible of the front and rear walls at ground-floor level and, indeed, very little now survives. In contrast, on the first floor both walls survive in good condition (Plates 23 and 24; see also Plate 28 on page 25). Both are close

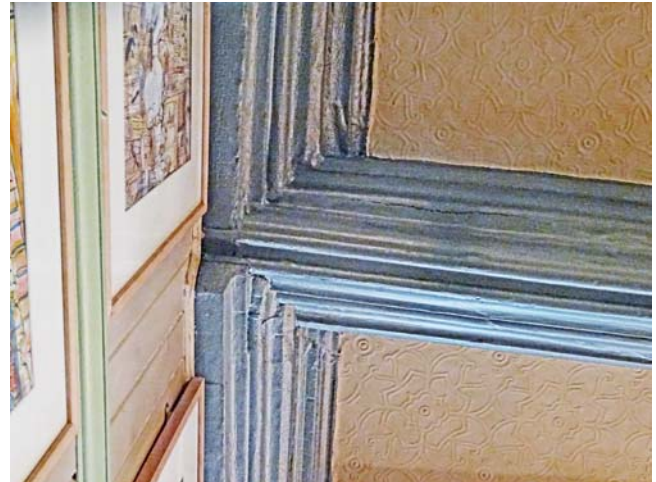
Crossbeam of truss K-K (left) and ceiling girder (right). The girder interrupts the crossbeam, its end being lodged over the side-girt in the adjacent period-C crosswing

the fact that when two were replaced they had to be notched in to position suggests that they are morticed-and-tenoned not only into the girder, but also into the rear side-girt (Plate 29). The joists are entirely plain and were from the outset intended to be masked from view by a plaster ceiling. In contrast, the girders and crossbeams are elaborately moulded (Plate 30; see also Plate 21 on page 23).

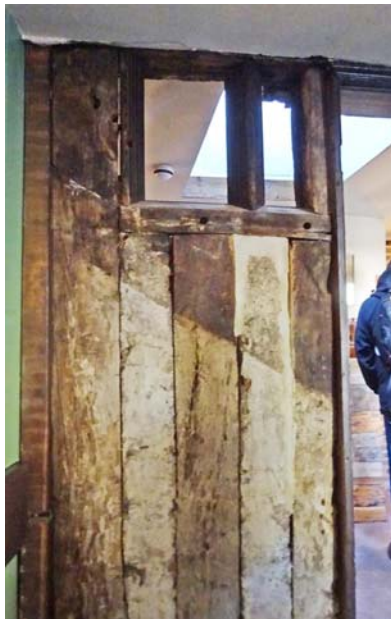
Plate 24
Surviving section of
clerestory window, close
studding and plastered
brick nogging in rear
wall of bay J-K

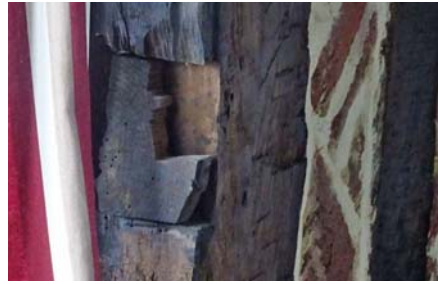
Plate 25
Joint for cill of oriel window, front
wall of bay J-K

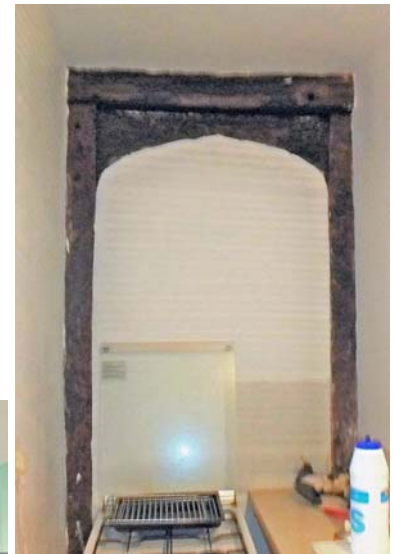
Plate 27
Western end of south wall,
north crosswing: inserted
period-D1 doorway with
arched head replacing plain
square-headed doorway of
period-B date on same site

Unlike at the south end, at the north end of the hall the doorway leading into the north crosswing was destroyed, probably because — being square headed — it was deemed too plain for the new high-quality hall. It was replaced on the same site by an arch-headed doorway, of which only the rear face is now visible (Plate 27). This modification would not today be identifiable had a new east jamb not been inserted hard against the period-B principal post. This was necessary in order to joint the new arched head into, and to continue the moulded/chamfered leading edge of the arch down the jamb. In order to maintain a doorway of adequate width, the inclusion of this additional jamb meant inserting the western jamb of the new doorway immediately to the west of the removed original period-B jamb, leaving a redundant mortice in the period-B crossbeam (see Plate 7 on page 8). On the western side of the doorway the new fireplace was positioned hard against the jamb of the fireplace.

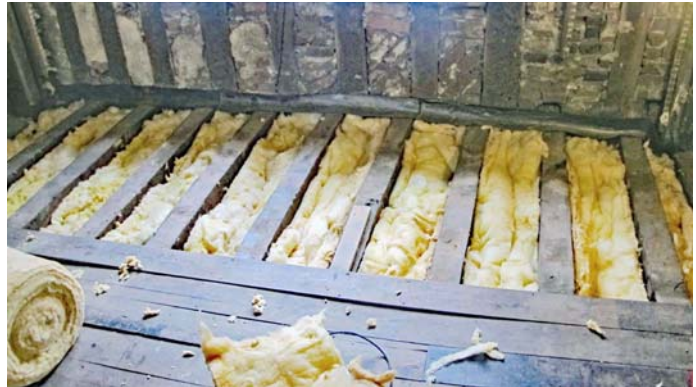
Plate 28

Joists supporting first floor within bay H-J, viewed during repairs. Note the front wall in the background, complete with jetty plate at its base

The joists supporting the first floor within the new two-bay main range span across the building, are trimmed into a central girder, and project at the front to support a former continuous jetty. They are today hidden, but photographs taken during the restoration of The Alma show them to be of square or near-square section and, at the front, closely spaced (Plate 28). In contrast, to the rear of the girder they are more widely spaced and

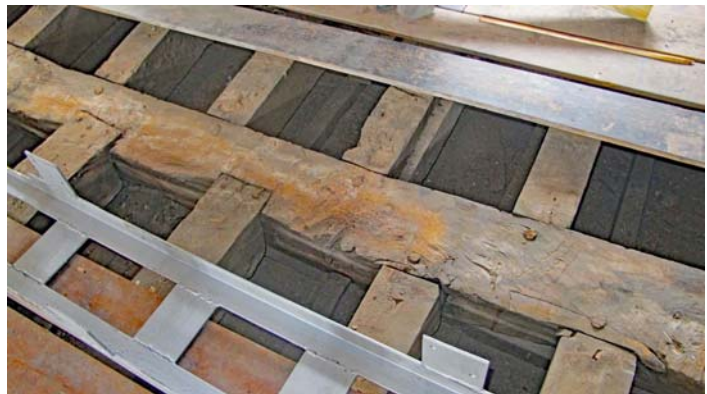
Plate 29

Joists and axial girder supporting first floor within bay H-J showing wider spacing of joists to rear of girder. Two of the joists in this area have been replaced

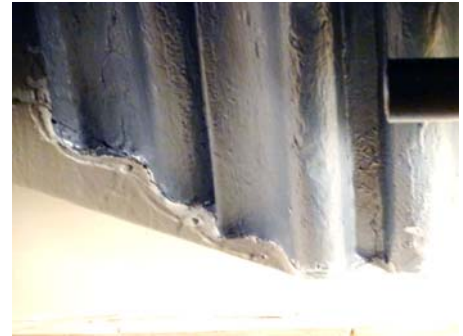
Plate 30

Moulding on ceiling girder, bay J-K

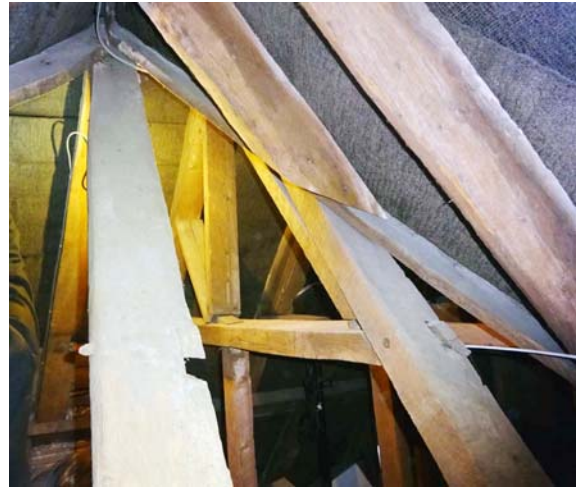
Plate 32
Roof over rear part of main range viewed from within the southern front gable roof

over the adjacent crosswings. Because of this, and the desire to incorporate a pair of projecting front gables, the off-centred ceiling girders were utilized as a wallplate onto which a roof, parallel but set back from the road, was pitched. This reduced the span to 4.65 metres (15ft 3ins) overall, and the height to 2.50 metres (8ft 3ins). This part of the roof is of simple paired-rafter-and-collar construction and uses rafters of 125mm by 75mm scantling supporting halved-on collars of 105mm by 65mm section (Plate 32). Projecting forward from the front slope at right-angles to it were two parallel roofs, originally also of paired-rafter-and-collar construction, but since rebuilt reusing some of the original material. These roofs are today hipped, but were formerly gabled and projected out into the road so as to weather the tops of the two first-floor oriel windows. At the intersection with the main roof, both roofs are carried on lay-boards nailed over the backs of the rafters in the front slope (Plate 32).

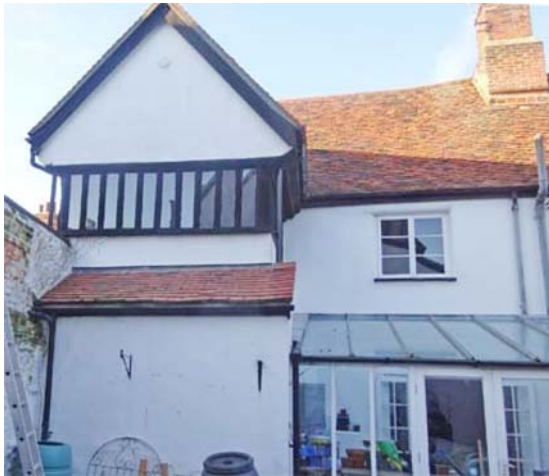
Plate 33
South wall of 'porch' with listed boundary wall (raised in height) on the extreme left and south wall of the south crosswing on the right

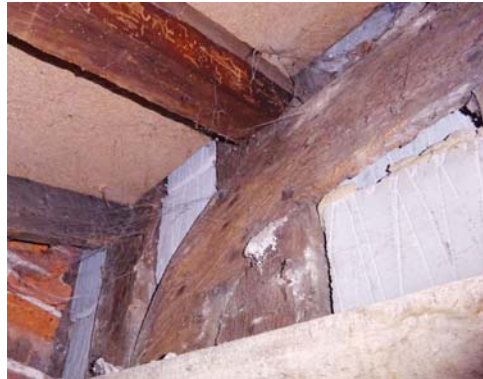
Plate 34
Base of ogee brace at west end of 'porch's south wall

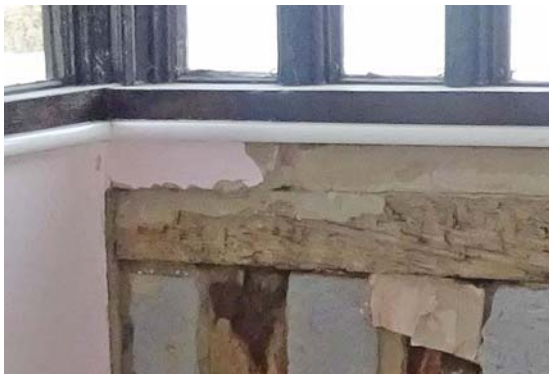
Plate 35
South-east corner on first floor showing chamfered top to window cill with the sawn-off corner post at the extreme left-hand end of the wall

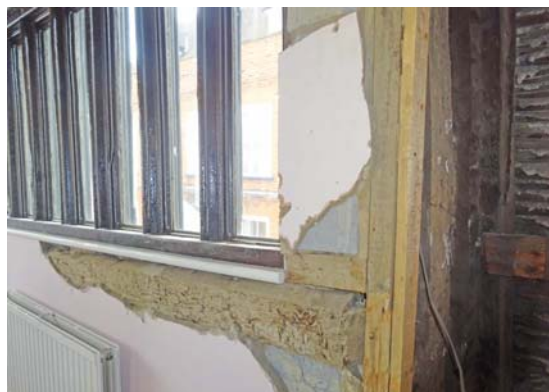
Plate 36
Northern end of west wall showing cill halved and nailed to side of stud in south wall of south crosswing

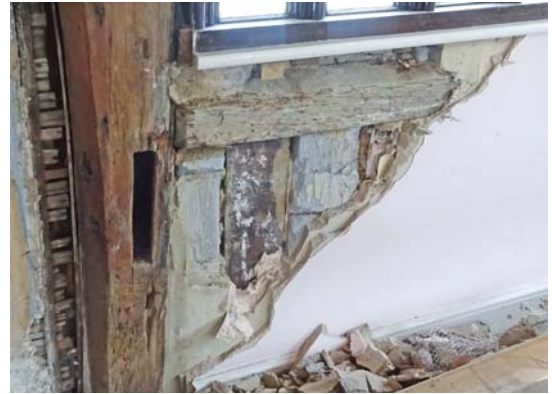
Plate 37

Northern end of east wall showing cill jointed into principal post F in south wall of south crosswing. The deep mortice relates to the cill of a removed period-C window.

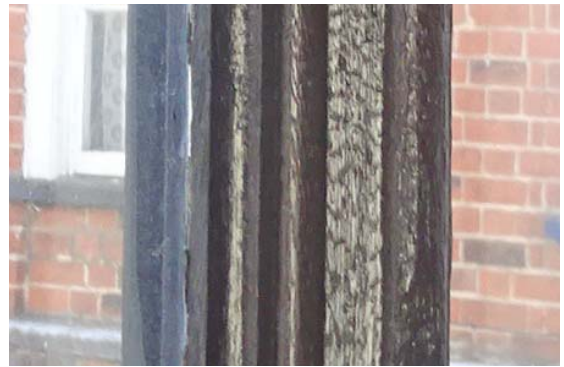
Plate 38

Detail of window mullion on first floor of 'porch'

The three windows running round the first-floor external walls of the 'porch' have been very heavily restored — the present cills are planted on top of the originals, the present window heads are modern, and all the mullions have been shortened to suit the present reduced height: some mullions have been replaced. As plates 35-37 show, the cills have a wide internal chamfer and the mullions are elaborately moulded to a profile which ought to date from the first half of the sixteenth century — mainly rolls and sunk chamfers (Plate 38). Mortices visible in the top face of sections of the original window cills indicate that the individual window panes have been replicated to approximately (but not exactly) their original width.

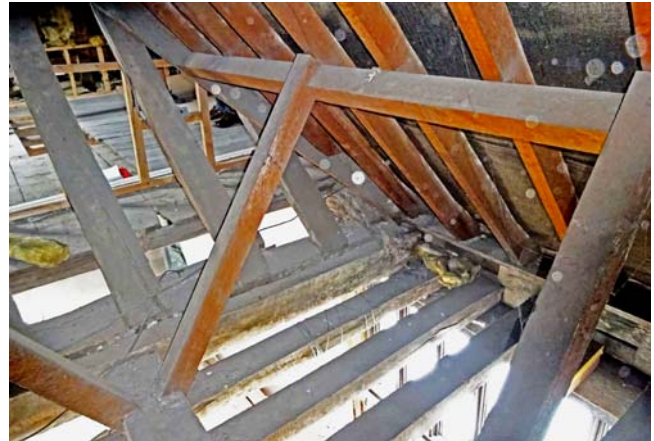
Plate 39

Ceiling in 'porch', viewed from south

Central-girder construction is also used for the ceiling on the first floor, but here the northern end of the 200mm by 130mm central girder is jointed into a 110mm by 195mm tiebeam positioned against the wallplate of the crosswing (Plate 39). The 140mm by 95mm plain joists are jointed into the girder at one end and lodge over the external side walls at the other, oversailing the east and west first-floor walls by 170mm. They are then jointed into substantial 'flying' wallplates 160mm wide by 200mm deep, each of which is fully moulded on its external face (Plate 40). Thus, measured overall the projecting joist ends and flying wallplates, the eaves of the 'porch' project 330mm proud of the first-floor walls. The ends of the flying wallplates joint into the northern tiebeam in level assembly, whilst a mortice in the soffit of the tiebeam (visible in plate 40) indicate there were originally brackets at this point. These brackets were removed when the posts which supported them were removed and the 'restored' windows extended up to the south wall of the crosswing. Within the 'porch' at this level there was a plastered ceiling

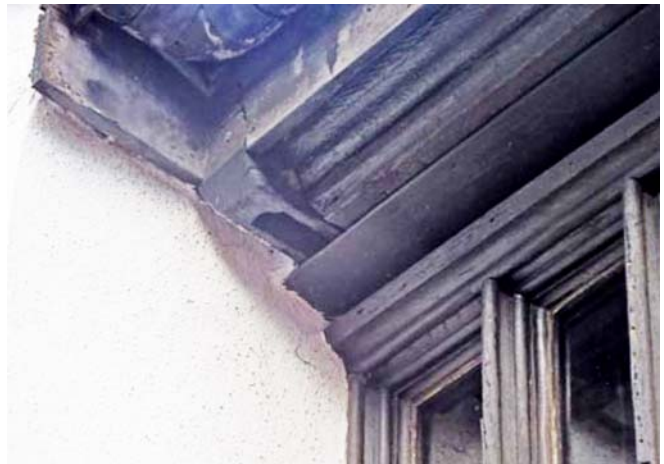
Plate 40

Eaves detail at northern end of west wall

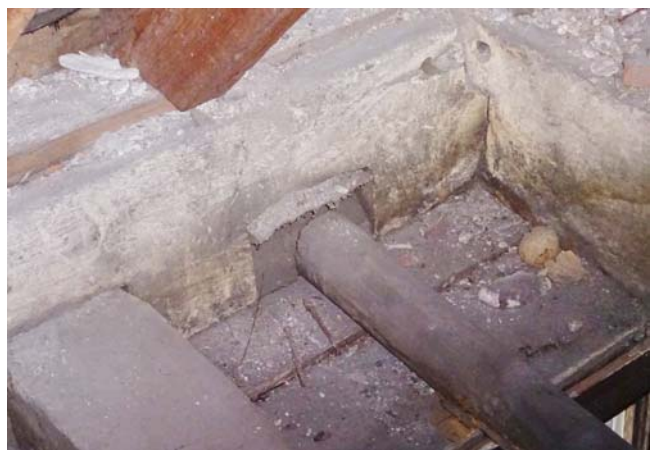
Plate 41

Detail of eaves adjacent to the west end of the north tiebeam showing empty joint in the inner face of the western flying wallplate where a removed joist indicates the joints to have been haunched bare-faced top tenons
