No 25 (The Alma) and No 26 Kings Head St Harwich, Essex

Harwich Architectural Survey: Paint Report

May 2020

Paint Report (Harwich Architectural Survey Project)

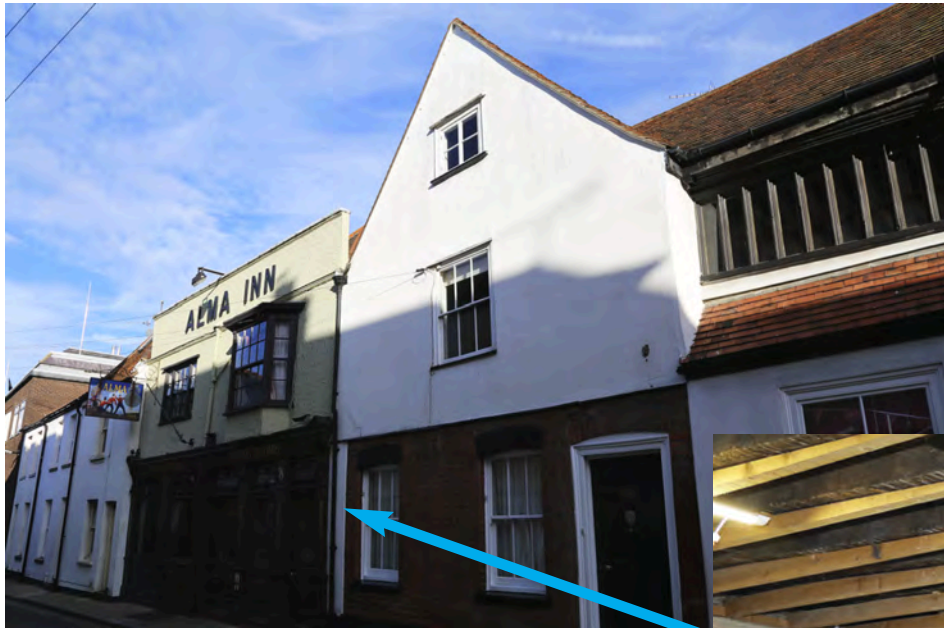
Plate 1

Left: exterior view of the Nos 25 (Alma) and 26 Kings Head St, Harwich. Paintings located on the north wall of the ground floor room

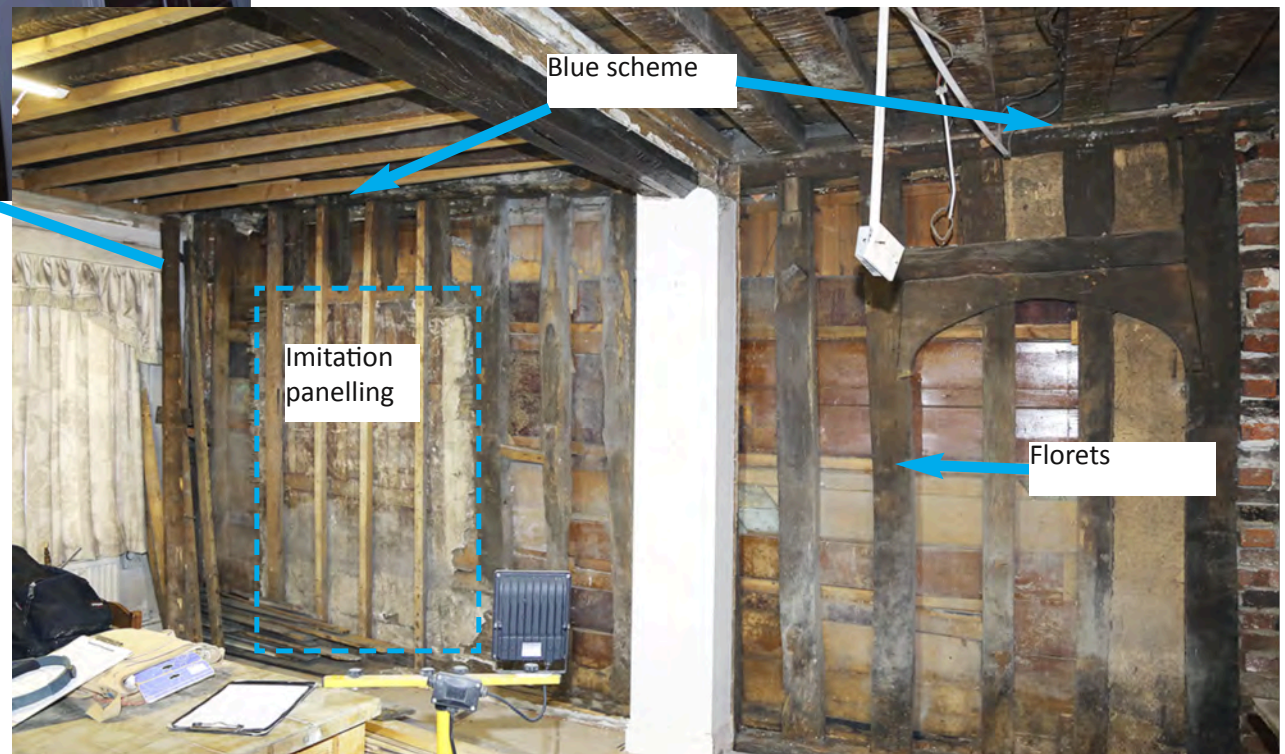
Plate 2

Below: view of the north wall with the remains of at least 3 decorative schemes from C16th and C17th.

There is one section of C17th imitation panelling at the western end of the north wall (approx 55" w x 59" h). The painting respects the position of the jetty which was later underbuilt. The scheme is carried on a lath and hair plaster support. The surface has a granular textured finish. The back of fragments of plaster can be seen at the western end of the north wall, indicating that the other side of the wall was lath and plastered. At the right

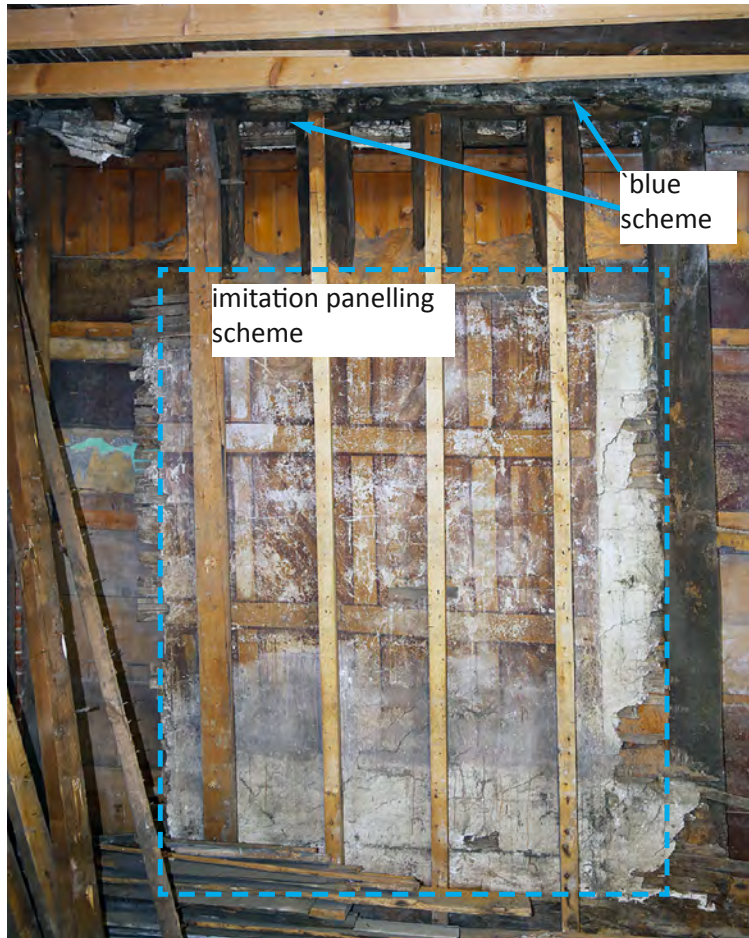
Plate 3

Left: view of the imitation panelling

The scheme consists of three tiers of panels, each consisting of 3 complete panels + 1 incomplete panel wide. The stiles are yellow/buff with panels in a bold, vigorous grained effect with yellow/buff and dark purplish brown using red and yellow iron oxides.

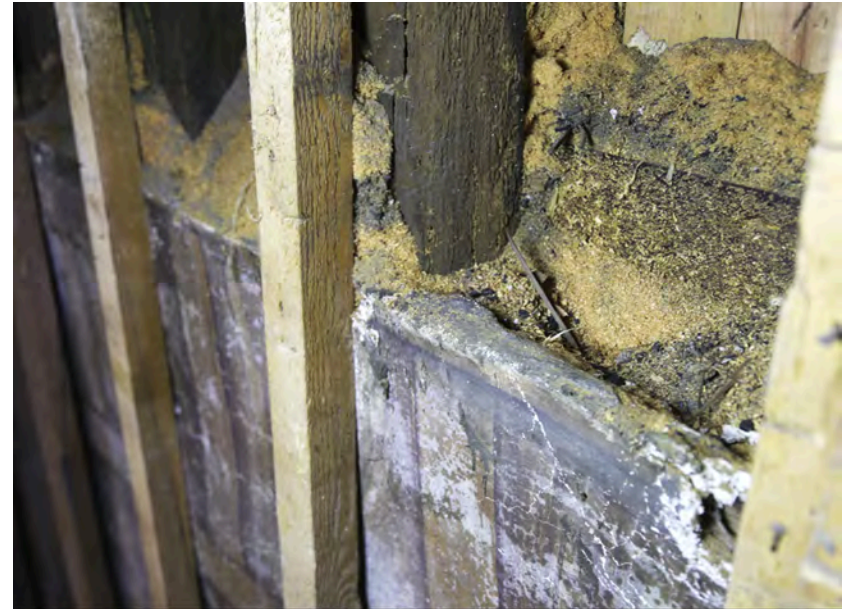
Plate 4

Top right: detail of the top edge of the painted plaster

The arrangement of the scheme is curious and seems to have been part of a decorative ensemble, perhaps with fixed seating/real panelling? The top edge of the painted plaster stops about 21½" down from the head beam. This was always intended so painted plaster abutted some form of fixed furnishing such as frieze paneling. Unpainted plaster at the right (+/- 7½" wide) and along the bottom (+/- 16" high from the sill) suggests that the imitation panelling might have been part of a mixed media decorative ensemble (?). It seems very unlikely that the white areas would have been visible. It is hoped that this can all be clarified during conservation work when more detailed analysis of the decorative scheme can be carried out.

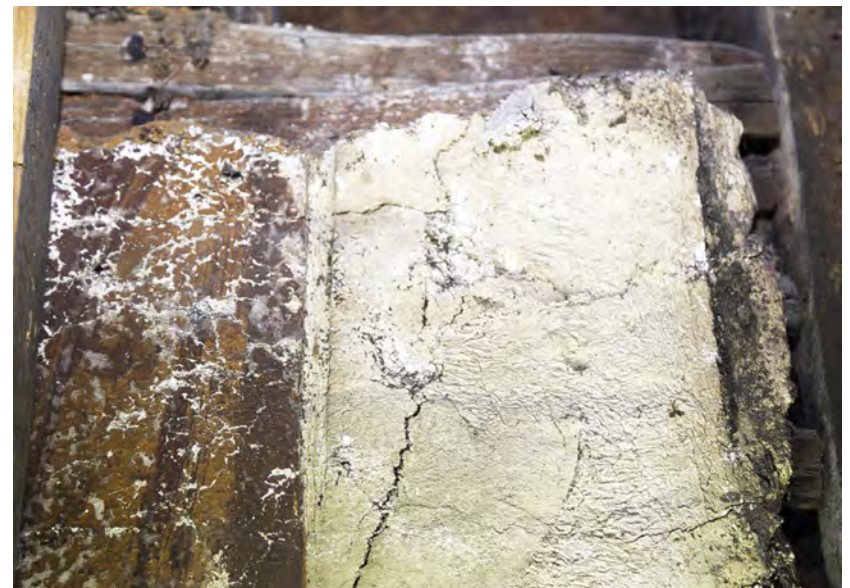
Plate 5

Bottom right: detail showing the texture of the unpainted section of plaster

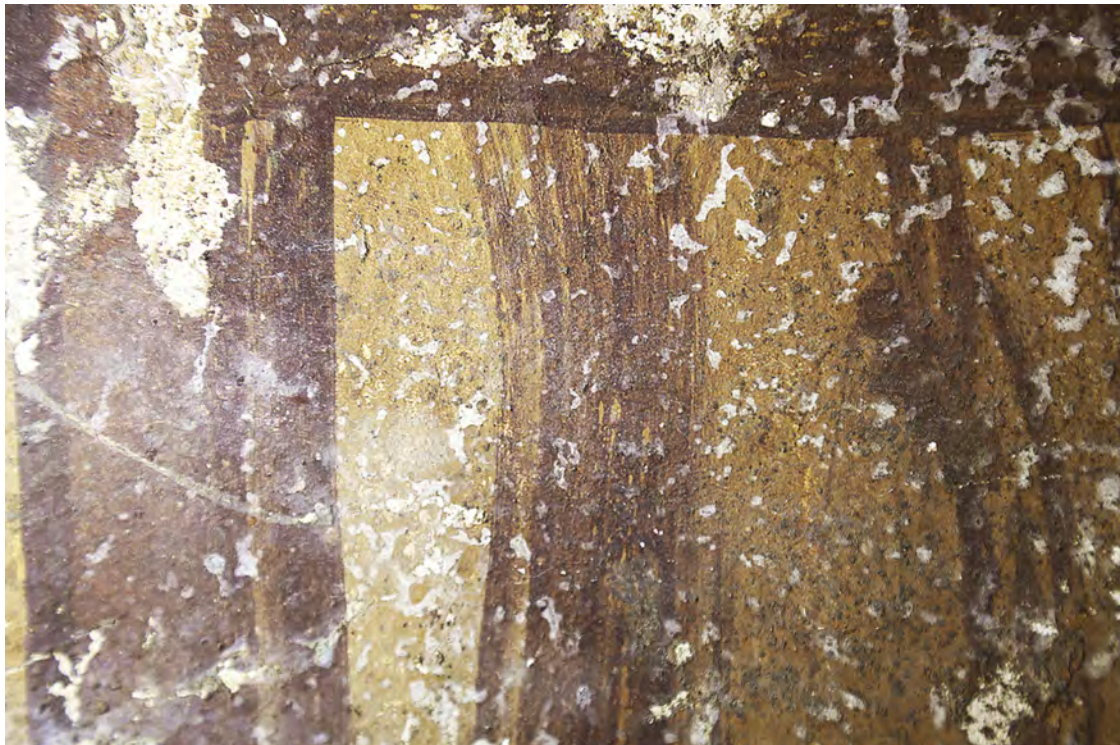
Plate 6

Below: detail of the imitation panelling showing the surface texture and paint losses

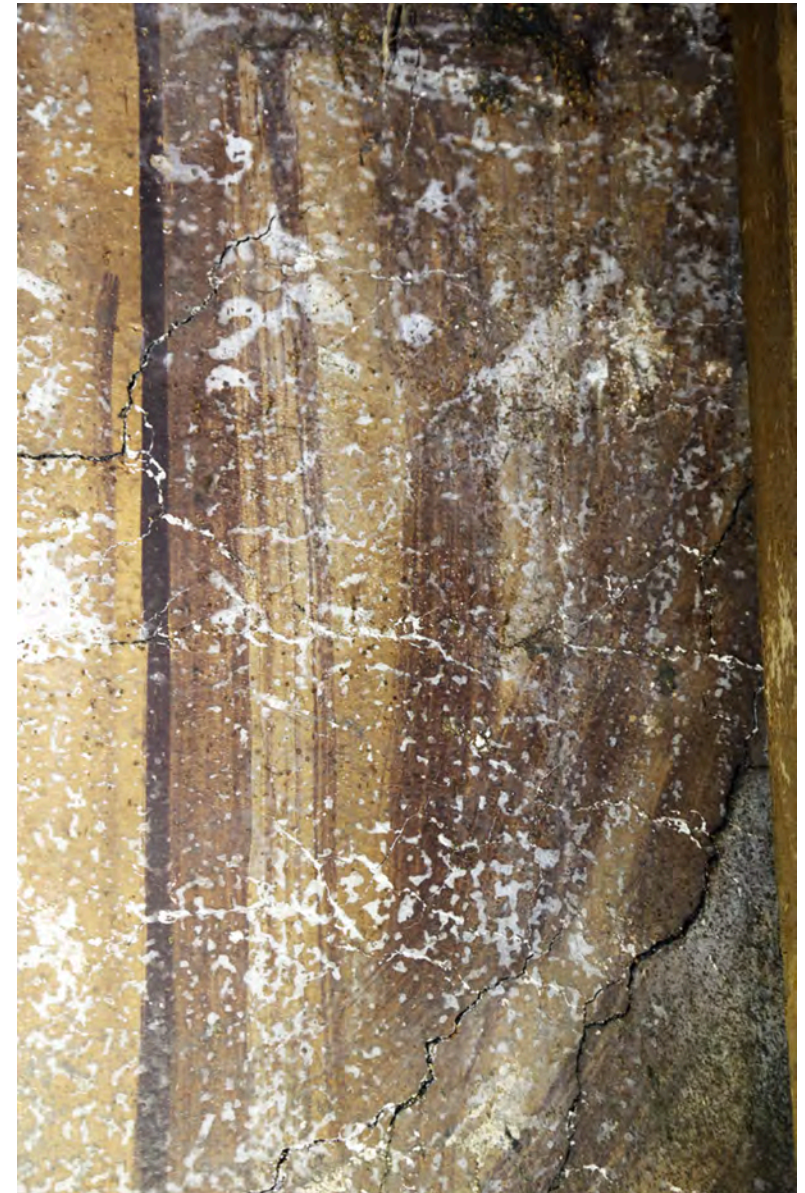
Plate 7

Right: detail of the imitation panelling scheme

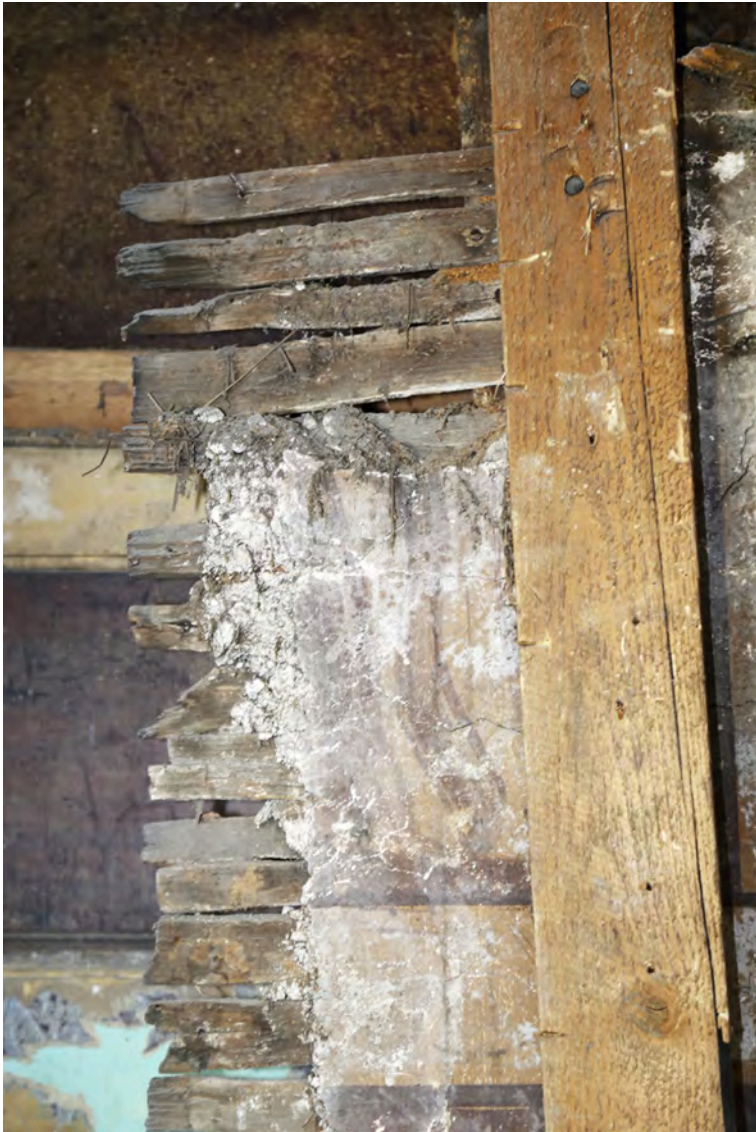
Plate 8

Left: detail top left corner (towards window)

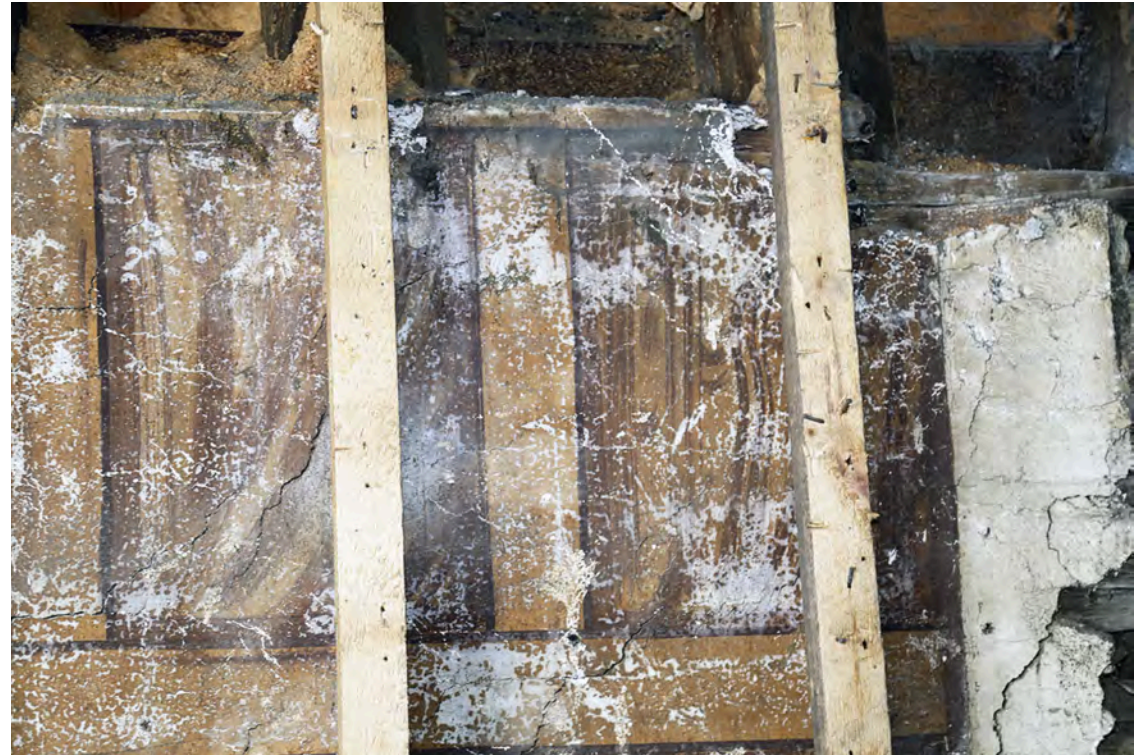
Plate 9

*Above: view of the top tier, right side panels, showing the unpainted plaster at the right
(All photos © Kirkham 2019)*

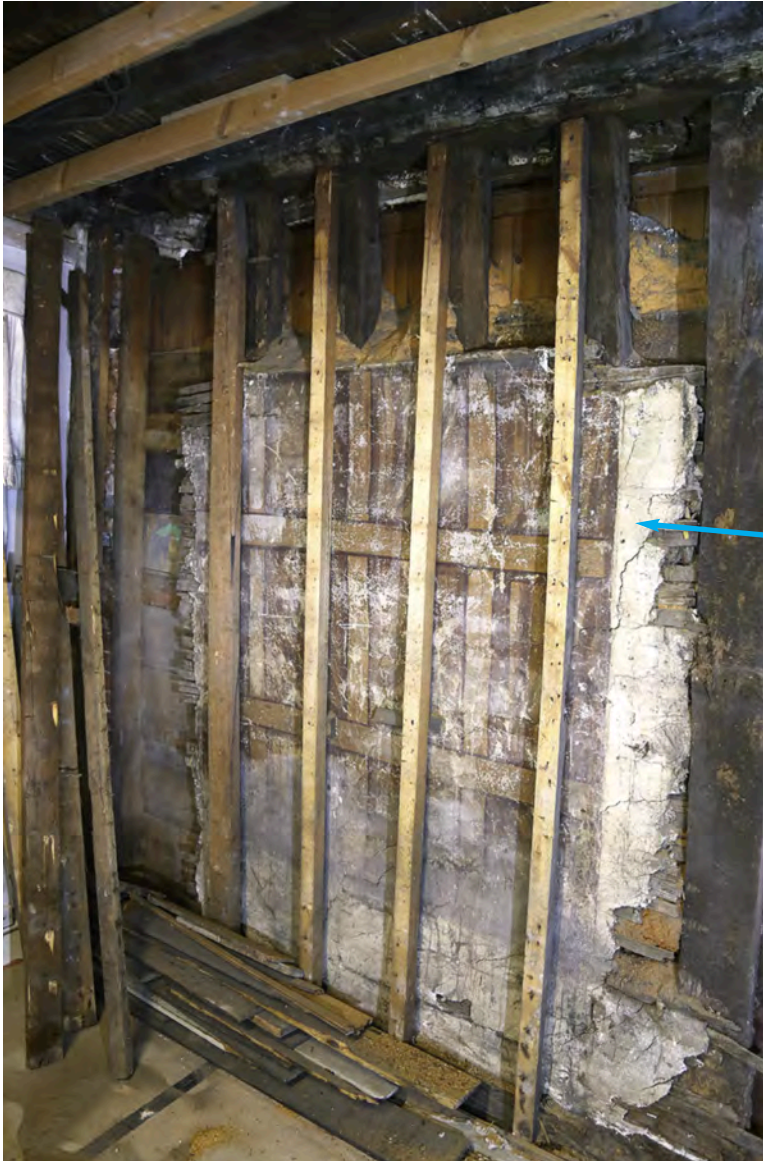
Plate 10

Far left: view of the painting, note the laths at the right edge: upper ones abut the side of the stud; the lower ones overlap onto the timber

side of the imitation panelling, the upper three quarters of lath butt against the side of the stud. The lower ones overlap onto the stud.

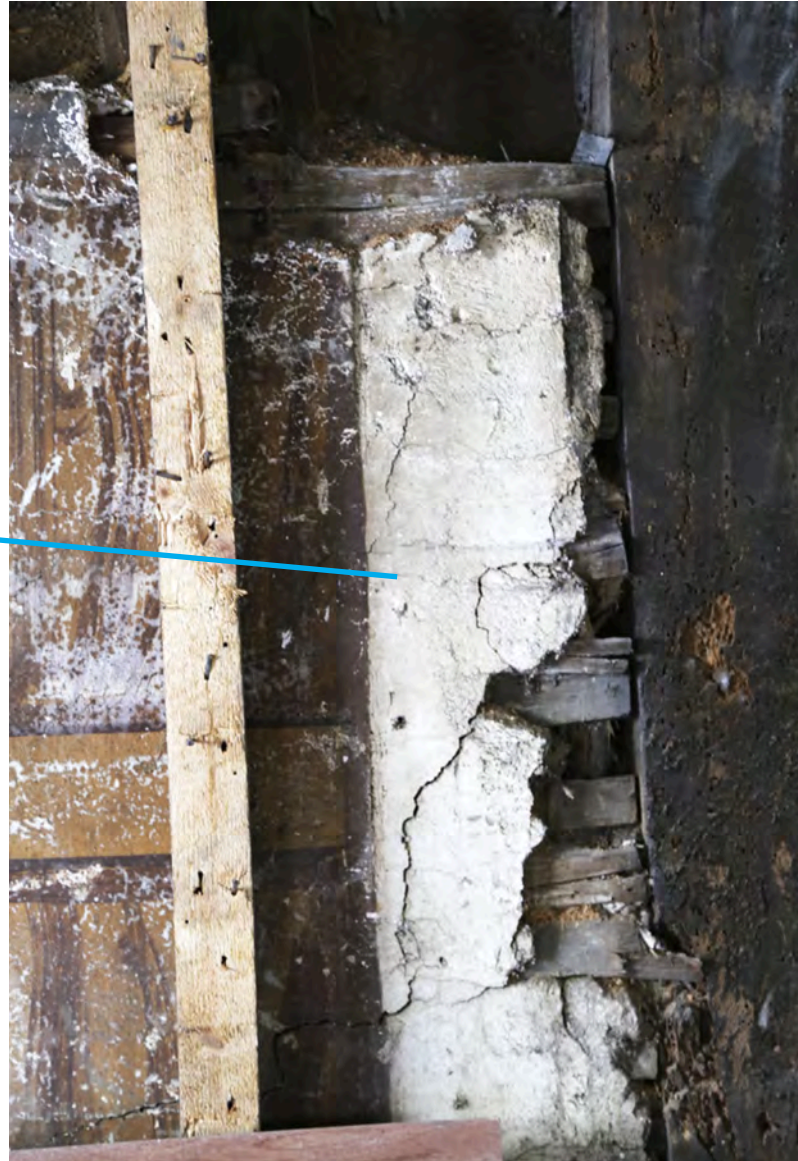
Plate 11

Left: detail of the lath and plaster in the upper right corner

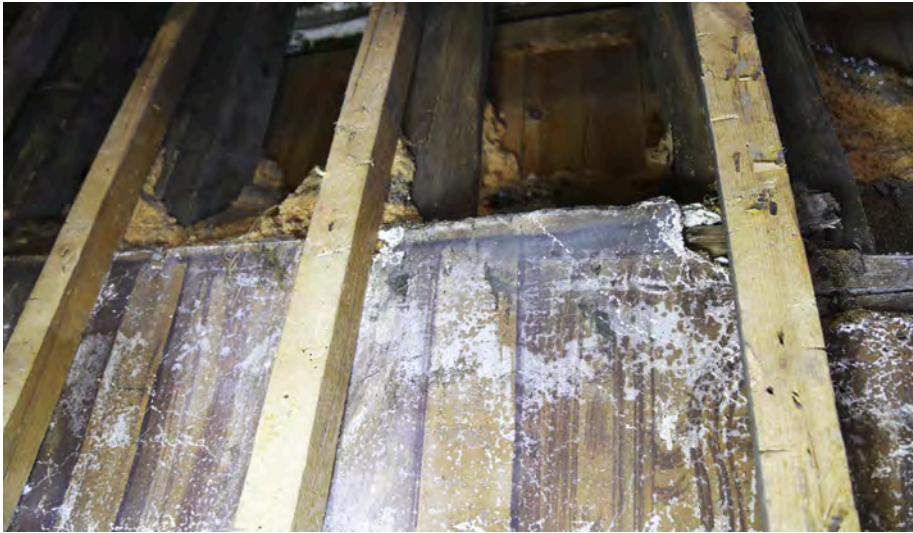
Plate 12

Left: view of the top edge of the imitation panelling scheme showing the damaged top right corner

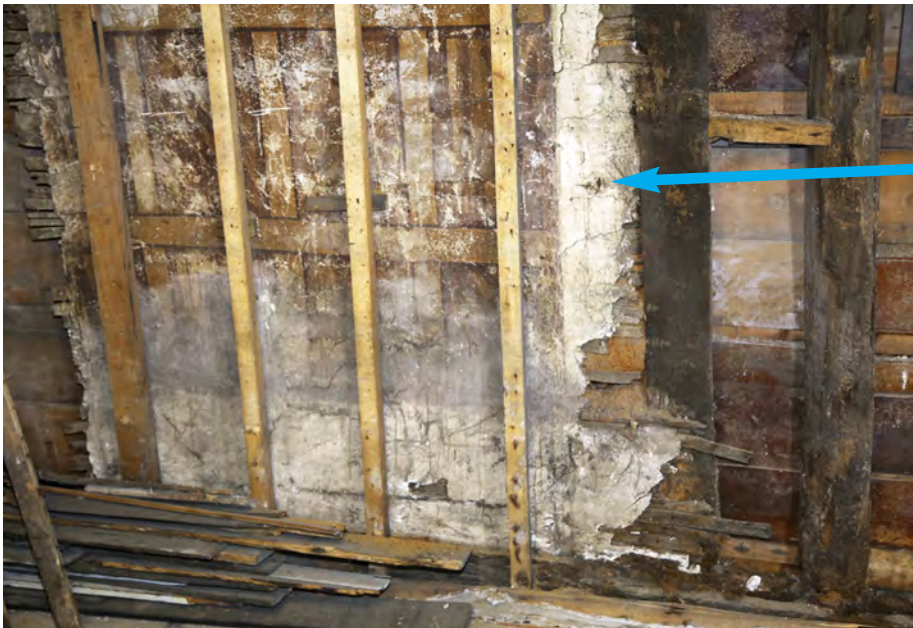
Plate 13

Bottom left: view showing the unpainted plaster along the bottom of the scheme and bottom of scheme obscured by a whitish 'veil'
(All photos © Kirkham 2019)

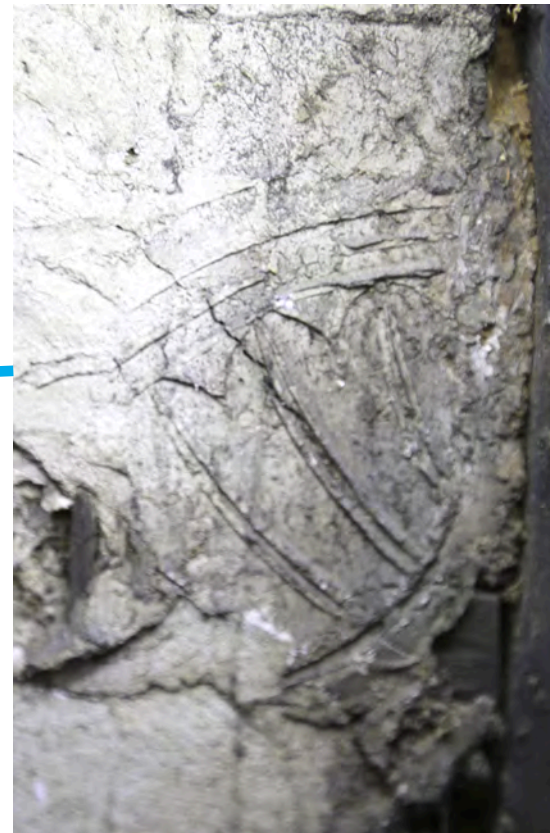
Plate 14

Left: scratched marks on the unpainted area of plaster at the right of the panelling scheme
(Photo © Kirkham 2019)

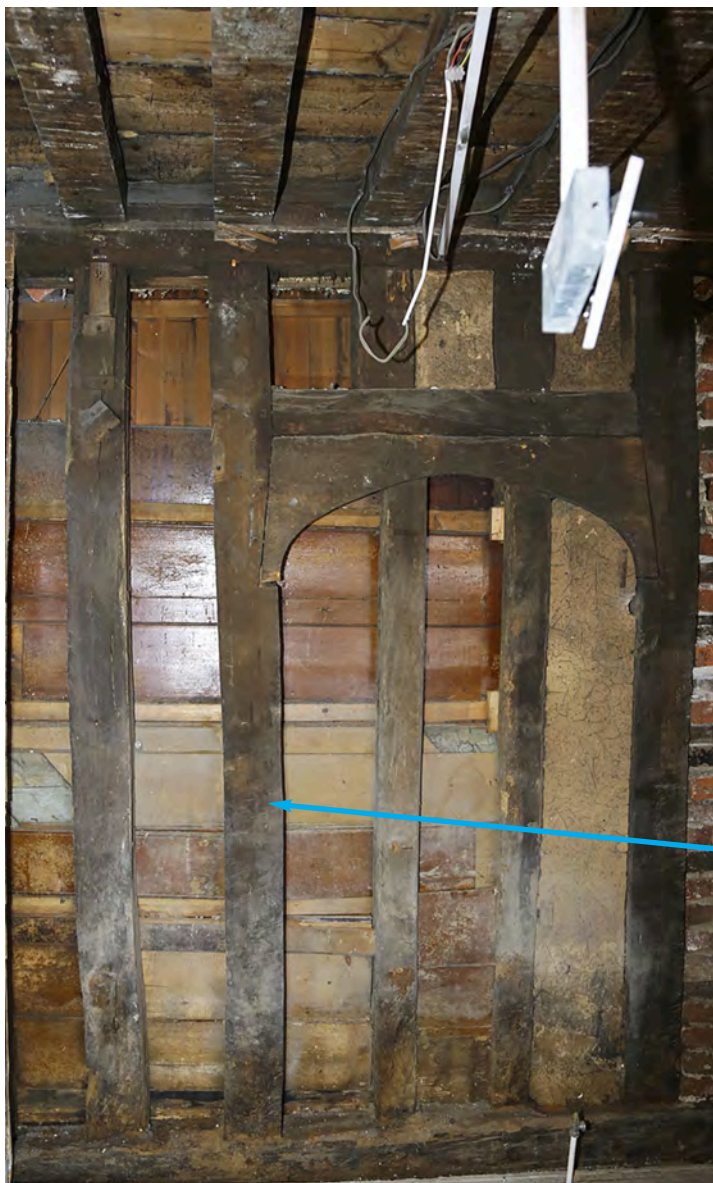
Plate 15

Far left: view of the blocked door with small red florets on the doorframe

It is thought that there are remains of yellow on the western side of the blocked doorway in the eastern bay of the north wall. Unfortunately, the paint analysis did not pick up any yellow, so it may prove to have been an optical effect. Forthcoming conservation work will allow another inspection. The red florets were a pigment mixture and were a brighter red originally.

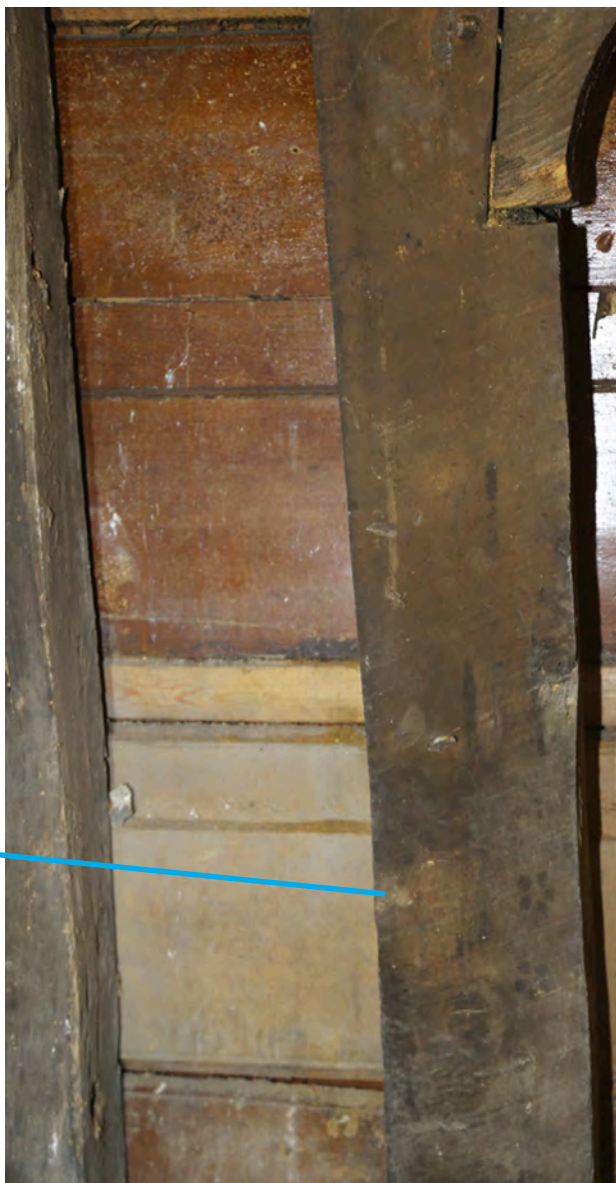
Plate 16

Left: detail showing of possible yellow and small red florets

The red used for the florets was a mixture of red lake and some red lead particles [p.9].

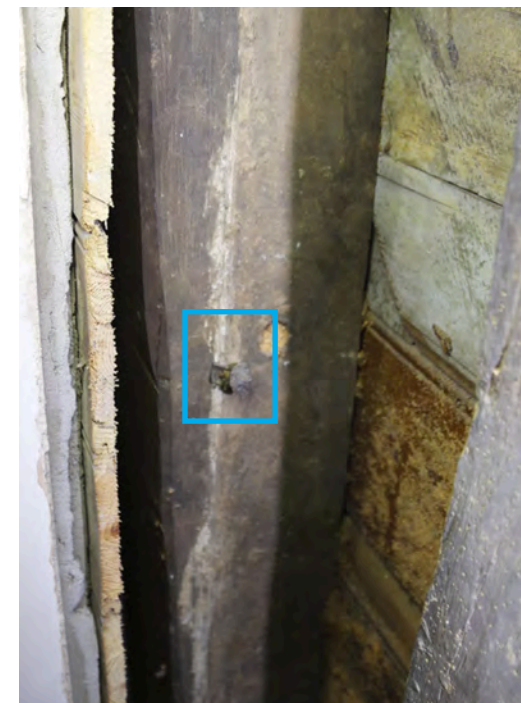
Plate 17

*Above: nail, perhaps a fixing for a textile
(All photos © Kikrham 2019)*

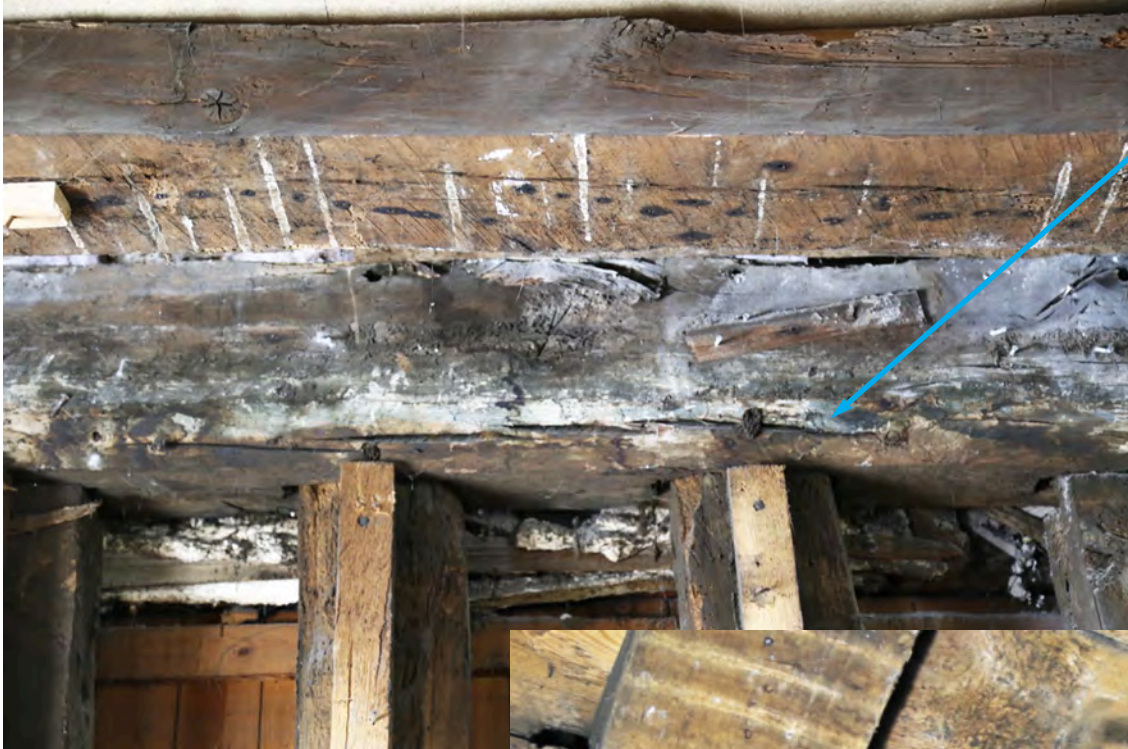
Plate 18

Left: detail above the panelling scheme showing the remains of blue paint

Remains of blue on the headbeam overlapped onto the hair plaster of the former lath and plaster ceiling (probably C17th?). How the rest of the wall was treated is unknown at this stage, it is unevenly and roughly applied but clearly extended the full length of the wall, across both bays. The analysis indicates an organic blue – probably indigo, typical for this type of scheme in the C17th. Was this scheme seen with some form of textile wallcovering?

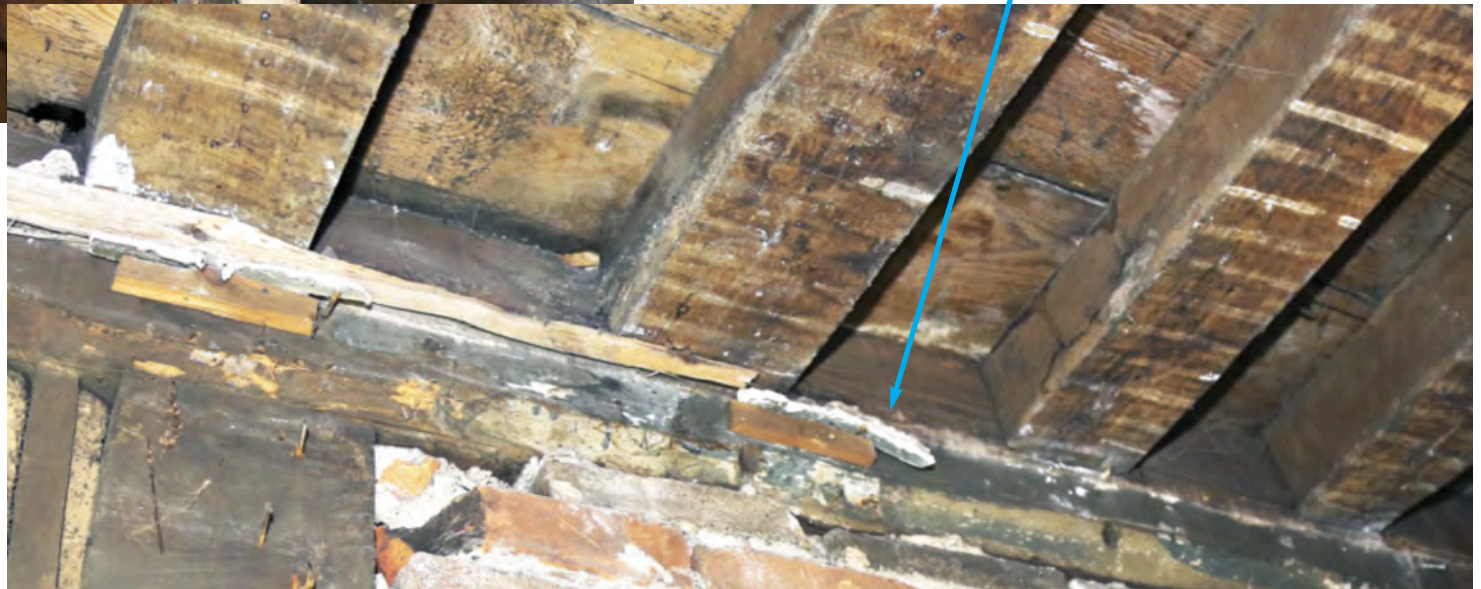
Plate 19

Bottom left: view of the beam at the eastern end of the north wall. There are remains of the 'blue' scheme with what appears to be paint overlapping onto the ceiling plaster (All photos © Kirkham 2019)

The three samples all showed the same two layers: a buff-coloured limewash tinted with ochre and some charcoal black, followed by a blue limewash tinted with an organic blue pigment [p.8].

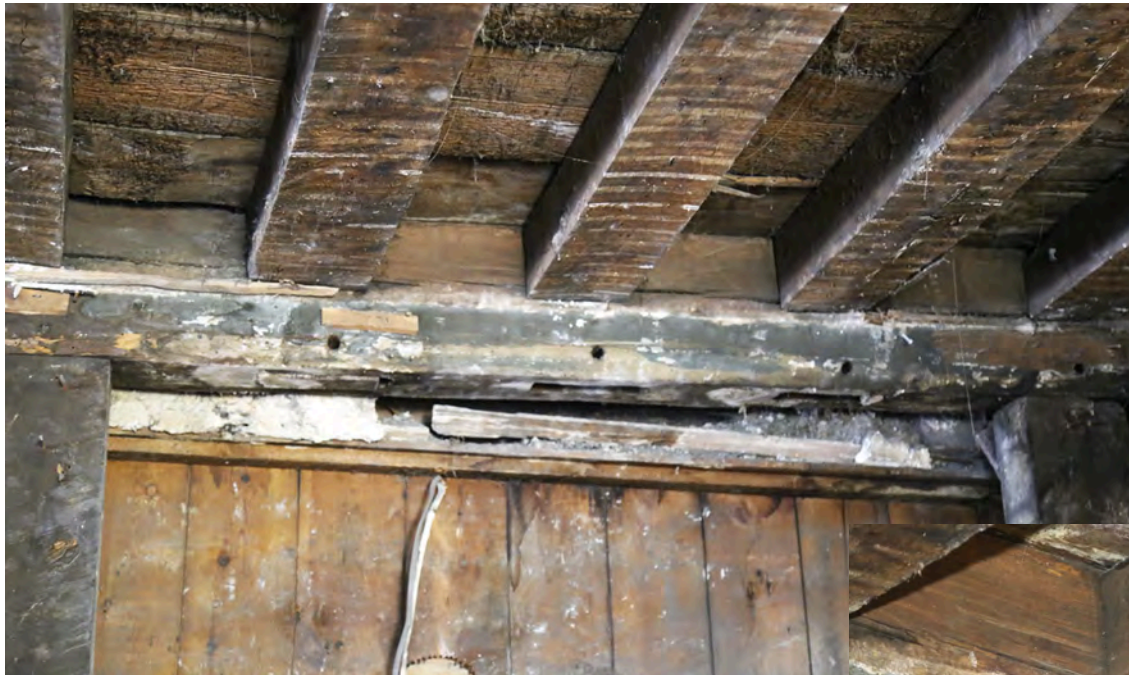
Plate 20

Left: beam with 'blue' paint

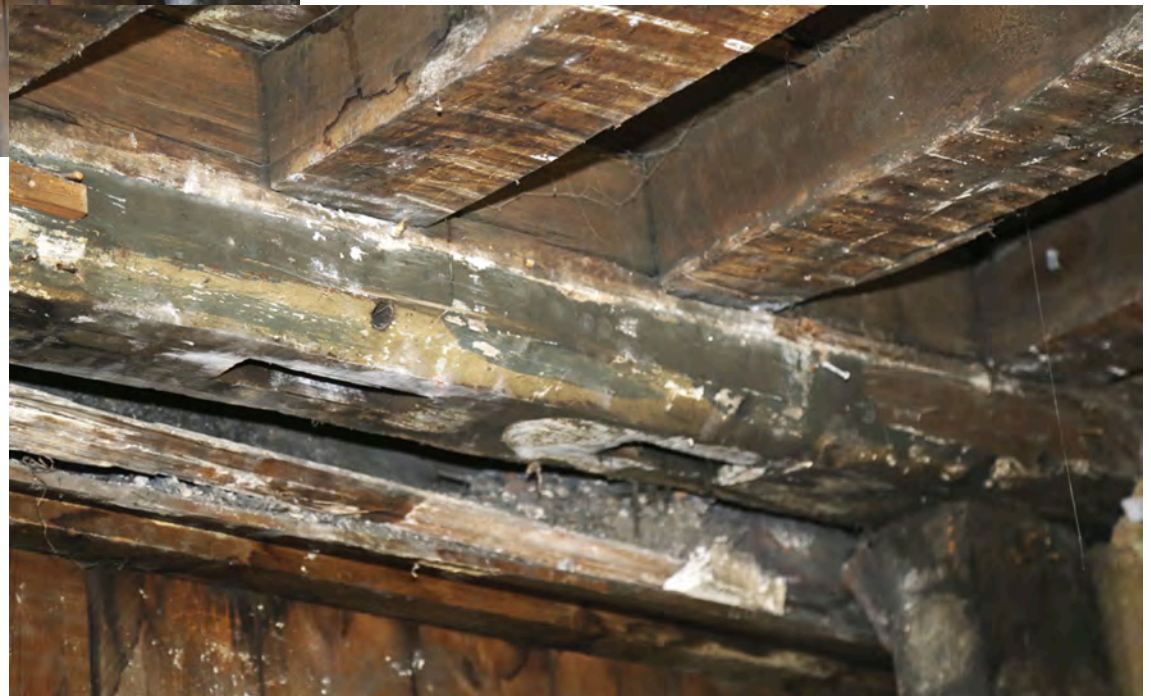
Plate 21

Below: beam with 'blue' paint associated with a lath and plaster ceiling

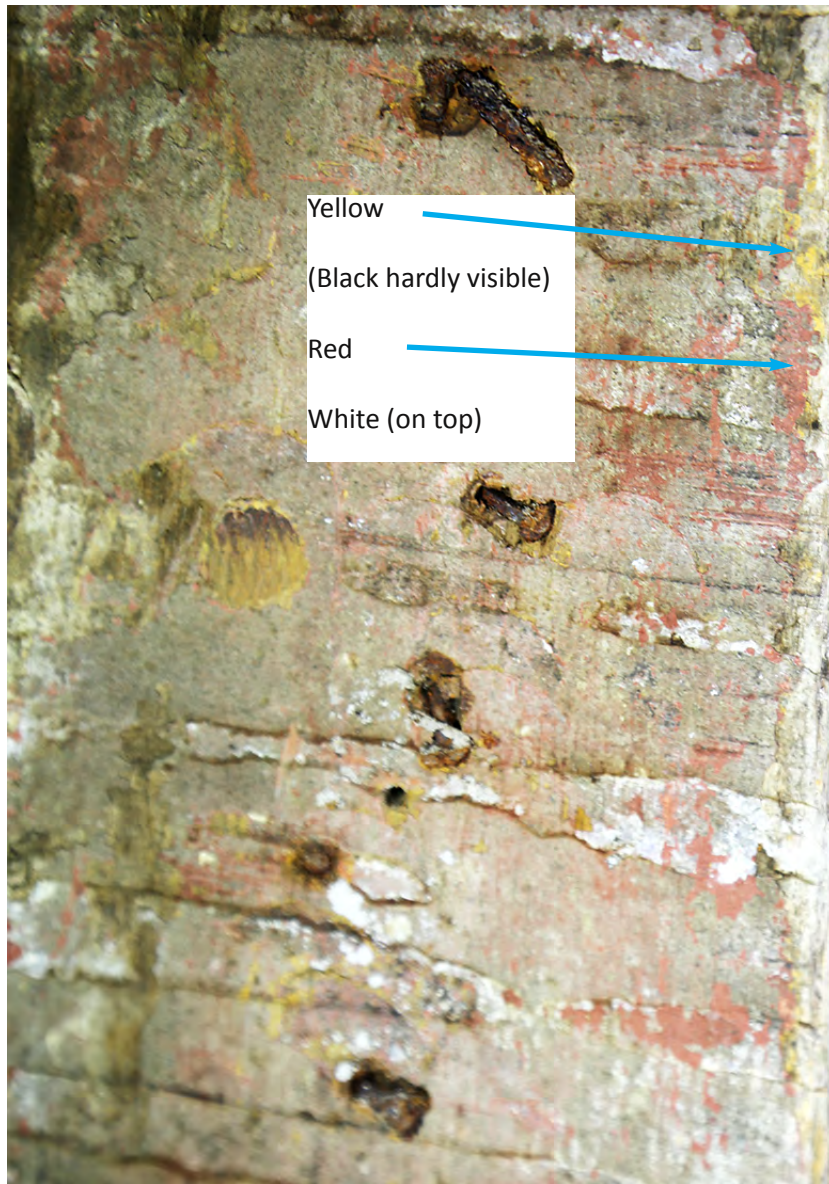
Plate 22

Left: detail of a painted stud showing the paint layers

Because they are out of context they are also difficult to interpret. The earliest scheme is a light yellow (assumed plain scheme), followed by black (assumed plain scheme) in two samples and then the red. These were later covered with limewashes.

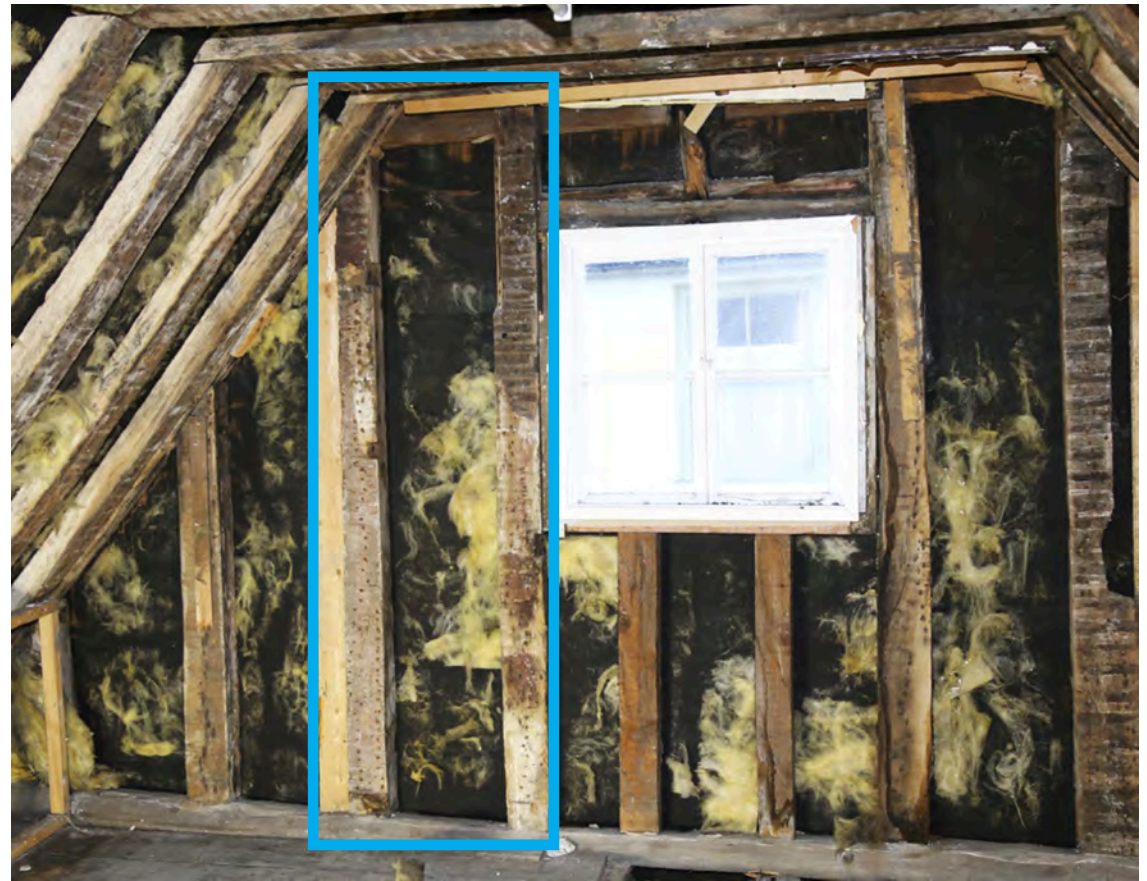
Plate 23

*Above: view of the front gable, attic, south crosswing showing the location of two *ex-situ* painted timbers*

Three paint samples were taken from *ex-situ* timbers in the front gable. These are probably remnants of plain schemes. While these paint schemes are impossible to date with certainty, they are most likely to be late C16th and early C17th on contextual grounds.

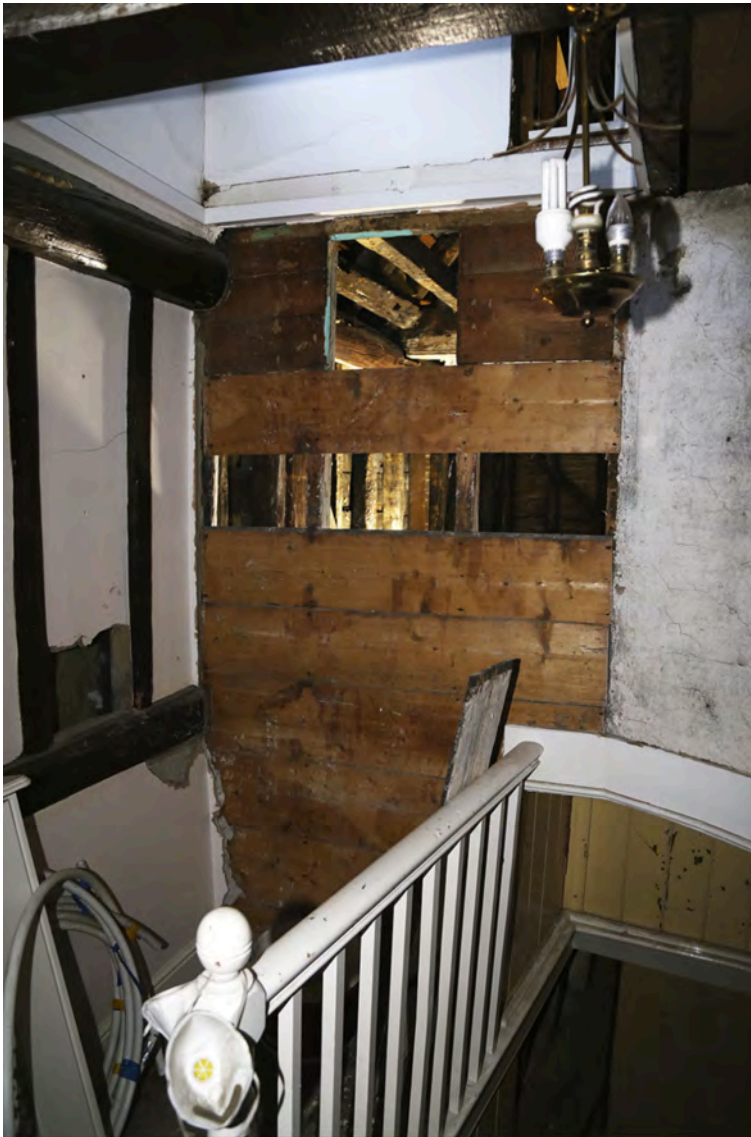
Plate 24

Left: view of the C18th stairs with horizontal boarding on the partition. The other side is painted.

This scheme is an unusual survival that cannot predate the installation of the stairs in the C18th. It is predominantly white with red borders – not unlike the plain schemes of an earlier period. The red also frames a window that allowed borrowed light for the stairs. The partition is constructed of horizontal boards nailed to thin section timbers. The flush face is onto the stairwell, apparently unpainted and the reverse side facing into the room is painted. It is worth documenting this scheme in more detail before being protected behind a false lining.

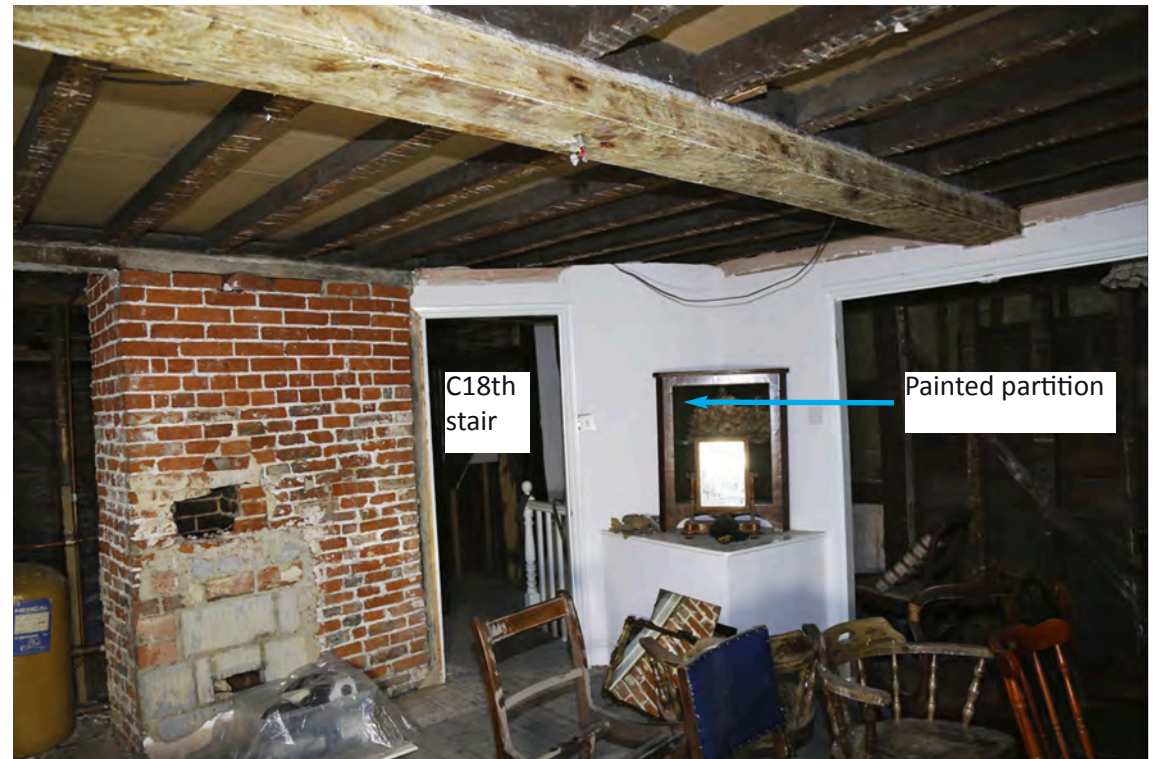
Plate 25

*Above: view towards the stair and the room containing the painted partition
(All photos © A Kirkham 2020)*

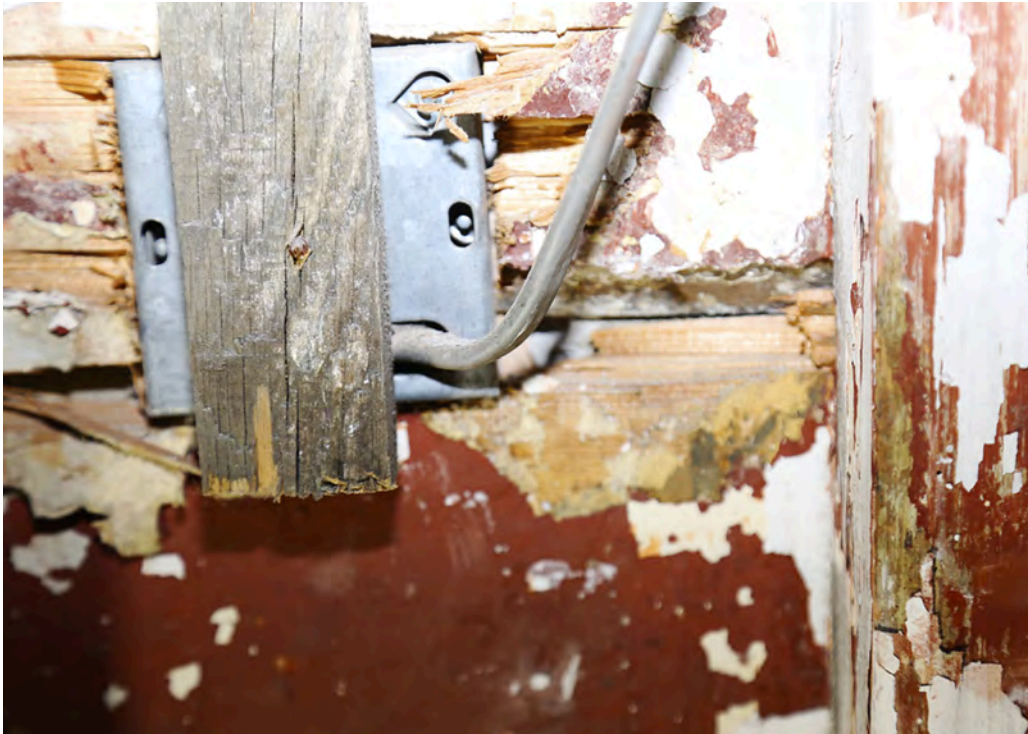
Plate 26

Above: detail to the left of the partition. Remains of the C18th scheme survive under later layers

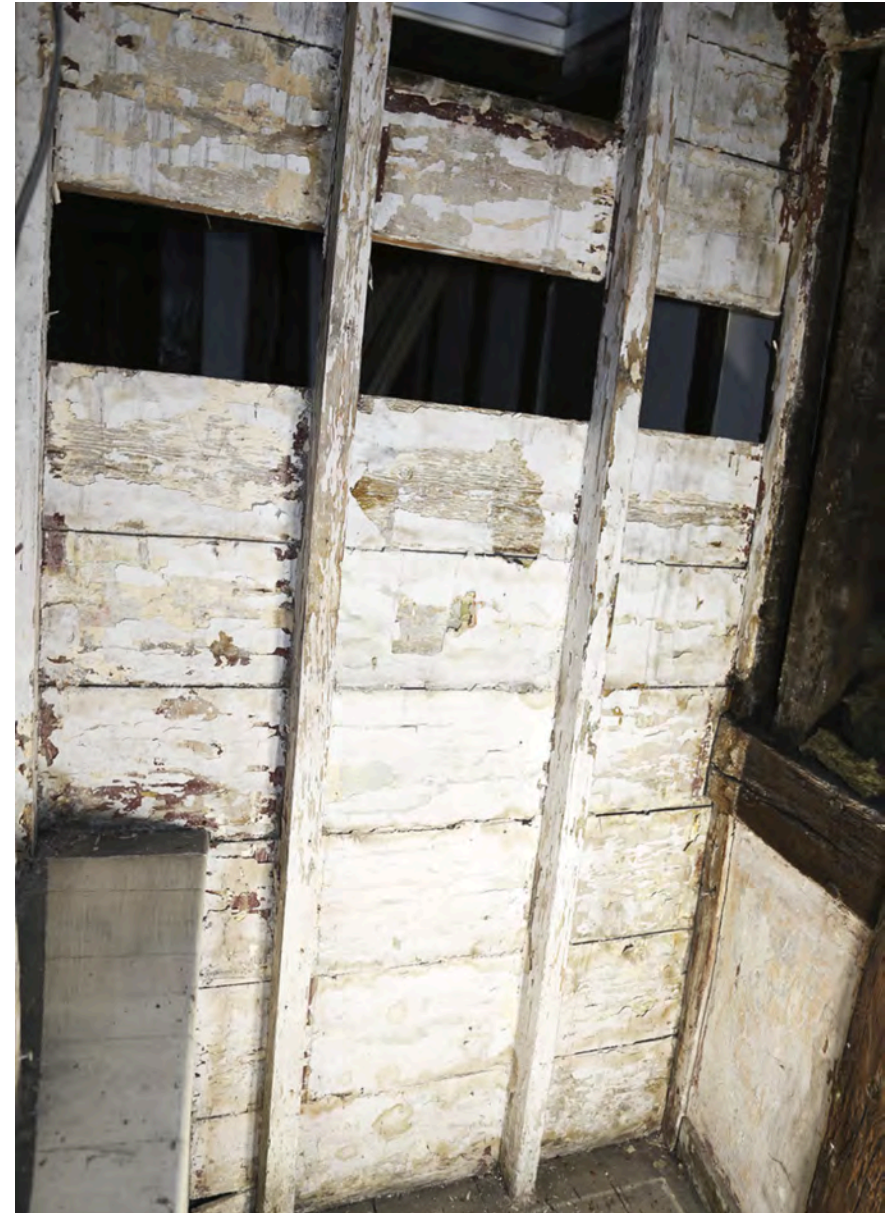
Plate 27

*Right: the painted partition which is mostly white with red borders
(All photos © A Kirkham (2020))*

The dark red visible today on the partition is a layer of pure red iron oxide. The density of the layer suggests it could be in an oil medium.
