No 25 (The Alma) and No 26 Kings Head St Harwich, Essex

Harwich Architectural Survey: Paint Report

May 2020

Paint Report (Harwich Architectural Survey Project)

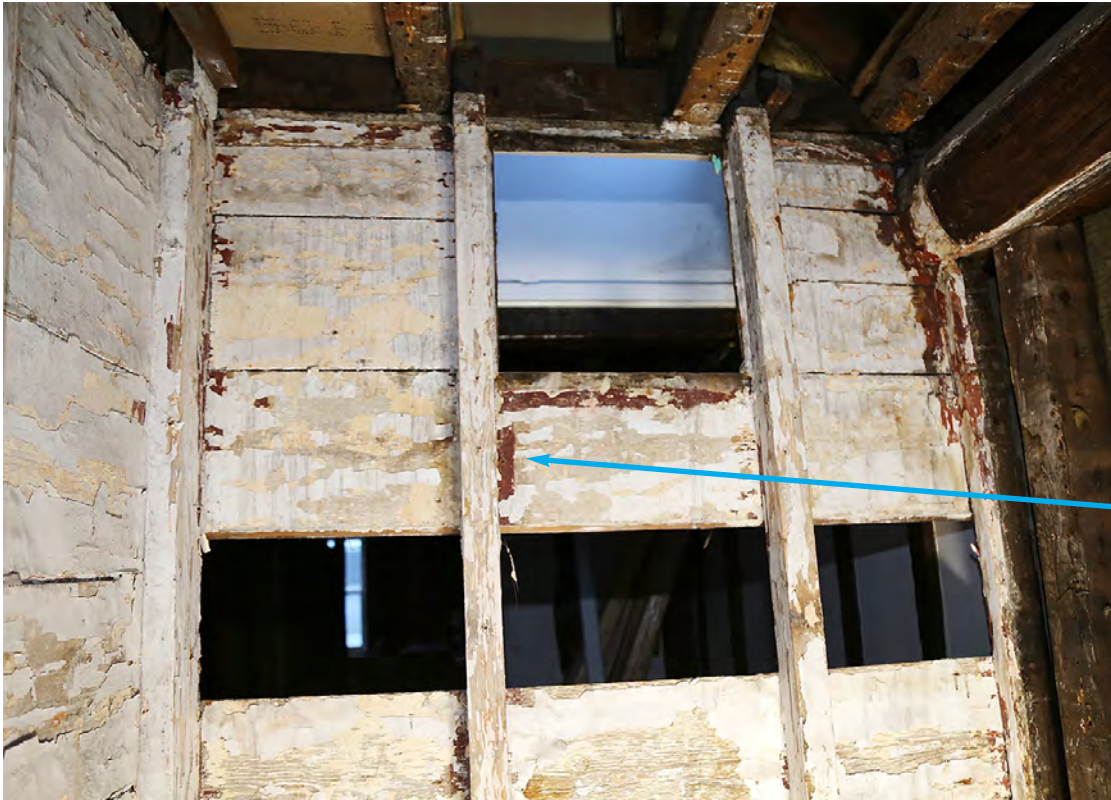
Plate 28

Above: detail of the boarded partition showing the red borders. There is some overlap of a later red in the top right corner

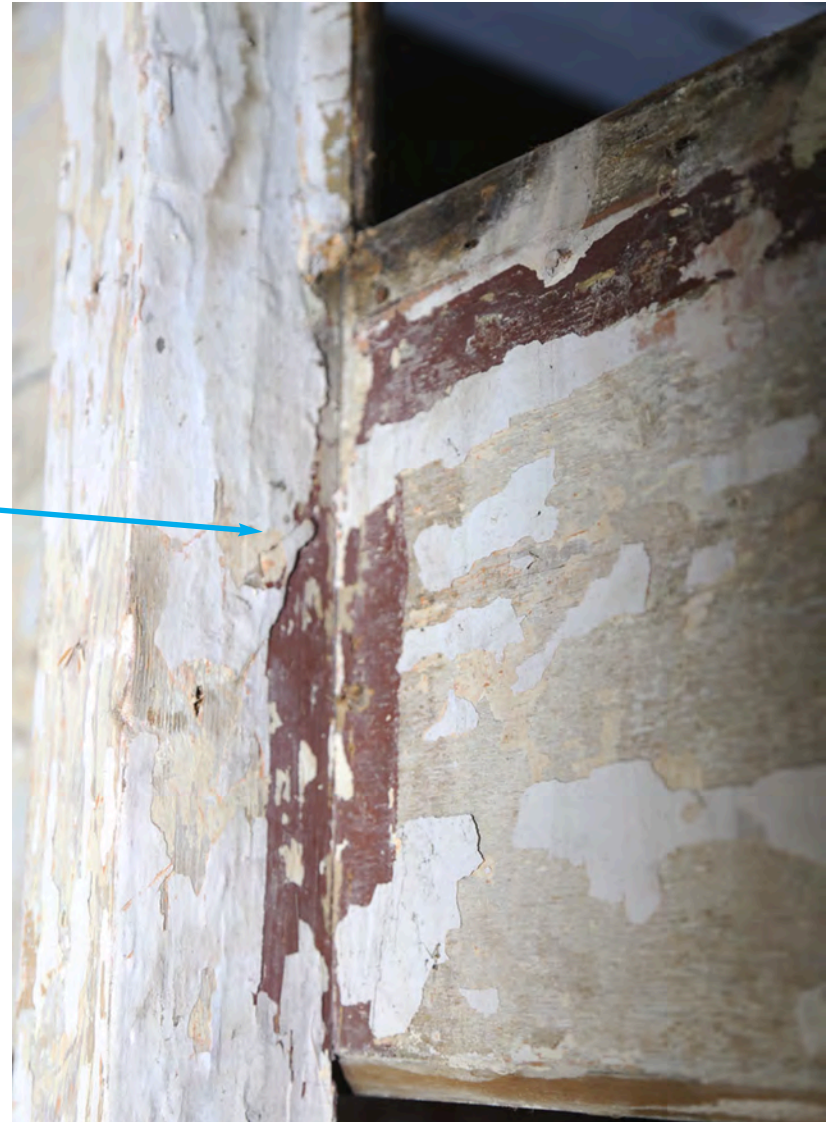
Plate 29

Right: detail of the border by the window. Later white layers are flaking off
(All photos © A Kirkham 2020)

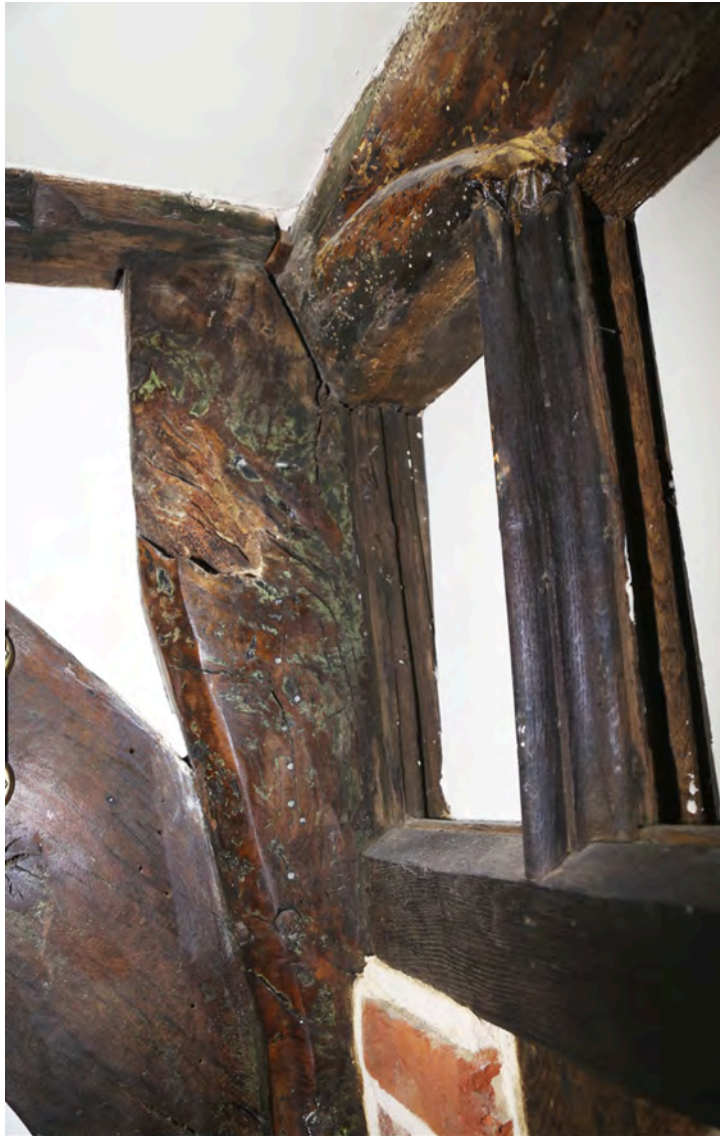
Plate 30

Green is clearly visible on timbers that have been less stripped. There is green from different periods of decoration. The earliest green is probably late C16th.

Left: detail of the post to the left of the blocked window (off photo)

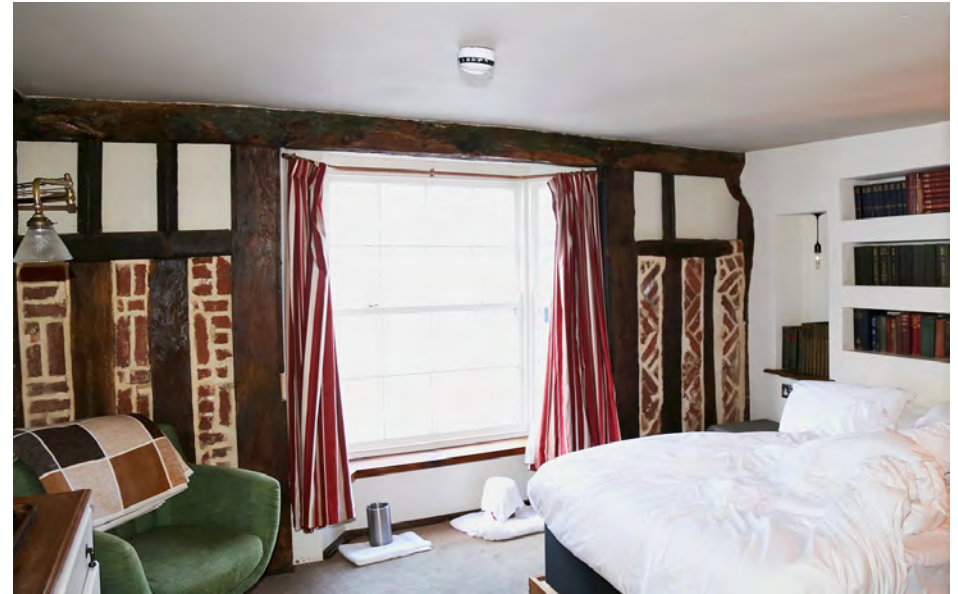
Plate 31

Top right: view of the front wall

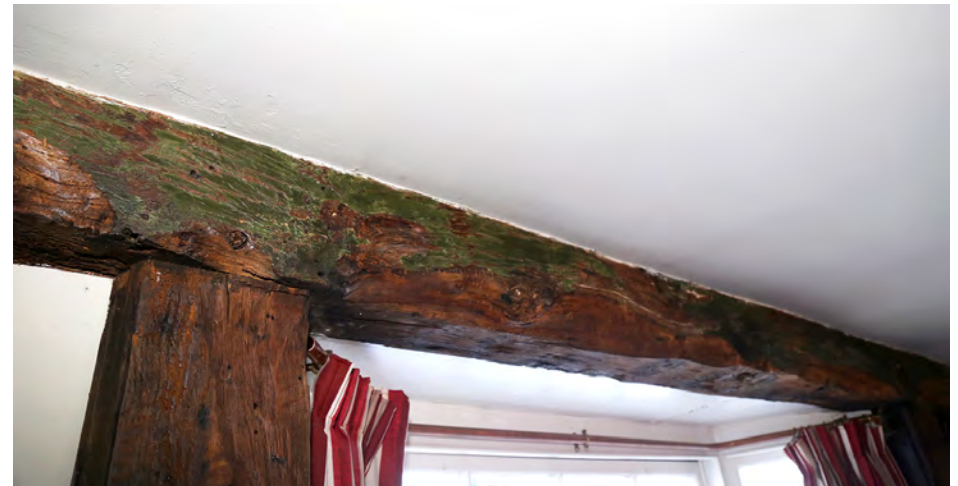
Plate 32

Bottom right: detail of the green above the window
(All photos © A Kirkham 2020)

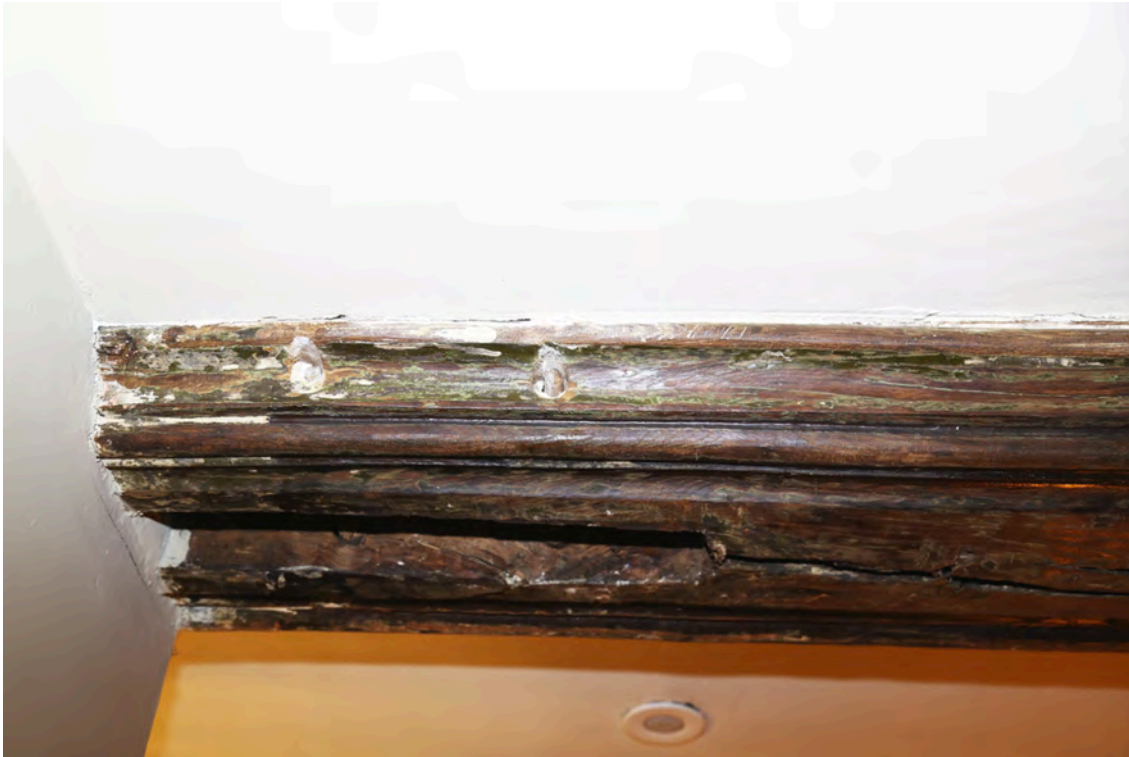
Plate 35

Above: detail of a ceiling beam now located on the landing

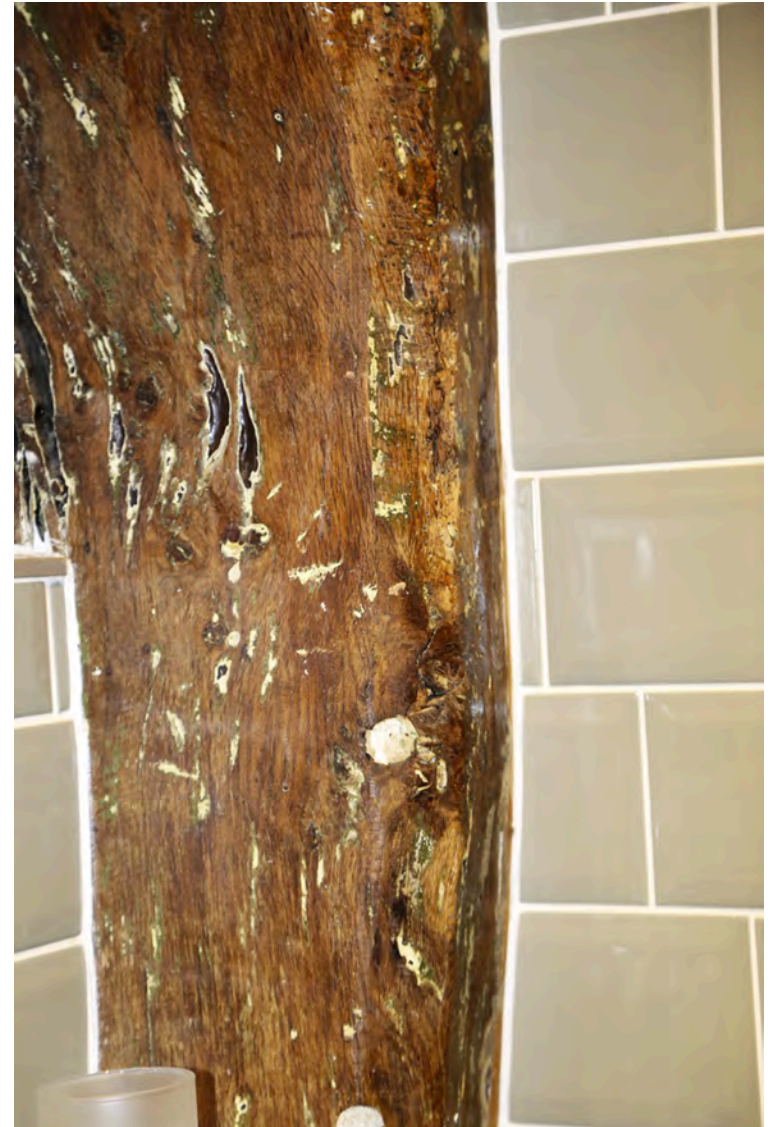
Plate 36

Right: detail of the post in room 3, showing traces of paint
(All photos © A Kirkham 2020)

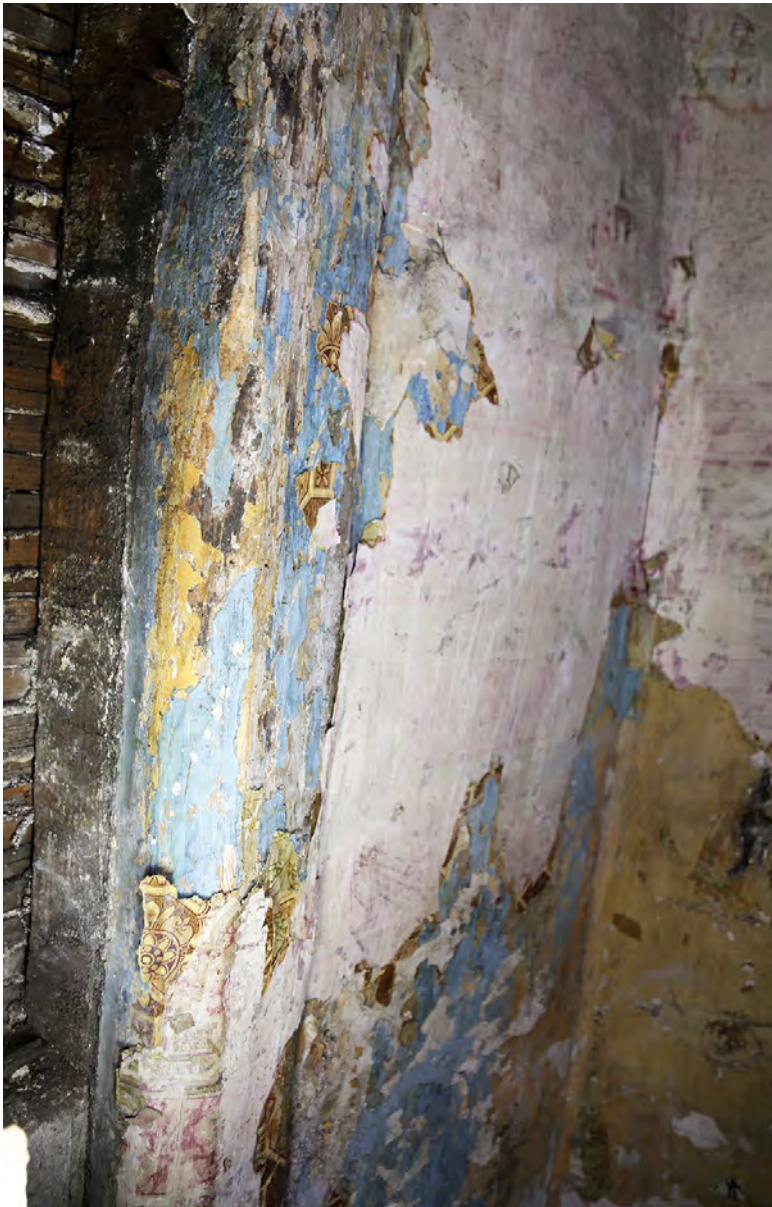
Plate 37

Left: detail, ground floor No 26, behind the stair, showing later yellow and blue schemes

Only one sample was taken from the later build at the east end which shows a sequence of whites, a yellow distemper and a later blue. The yellow distemper housepaint is seen in Suffolk and Essex vernacular houses, +/- c.1800. The blue pigment is Prussian blue so it could be a little earlier in the C19th than the blues elsewhere in Harwich.

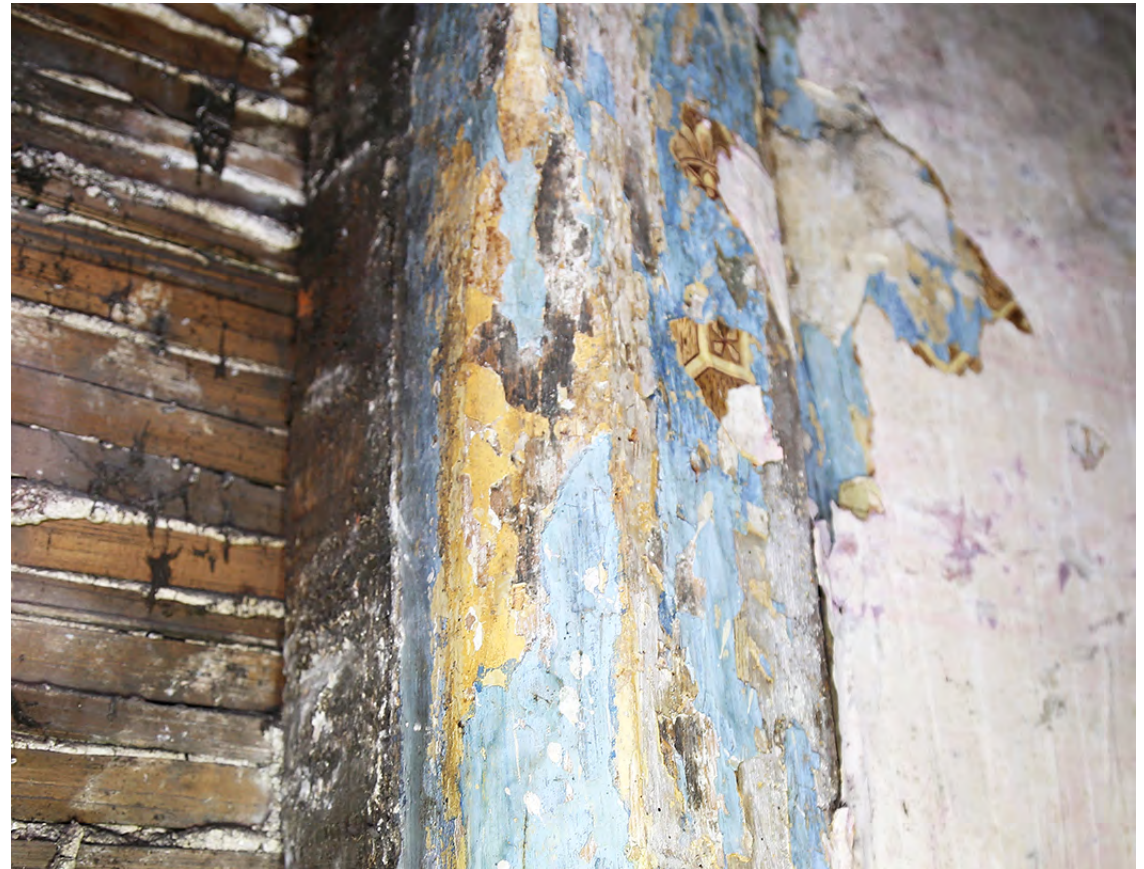
Plate 38

*Above: detail of the same area
(All photos © A Kirkham 2020)*

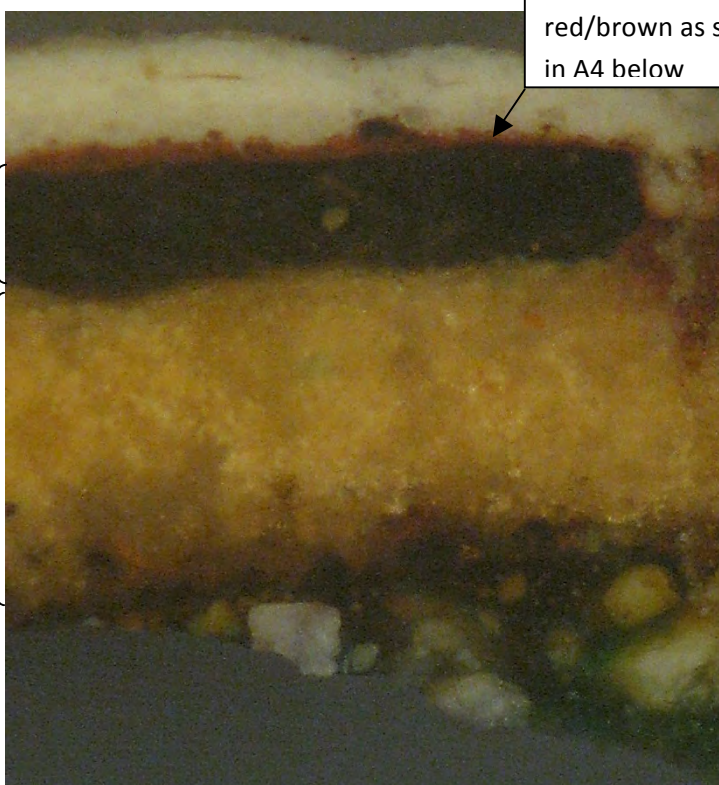
SAMPLE A2

Alma - Room 1 ceiling beam
green and buff

black

skim of plaster

copper green

In Samples A2 and A3 the green was followed by a layer of lime plaster so repairs may have been carried out to the ceiling. When the samples were taken this layer was seen as a buff colour.

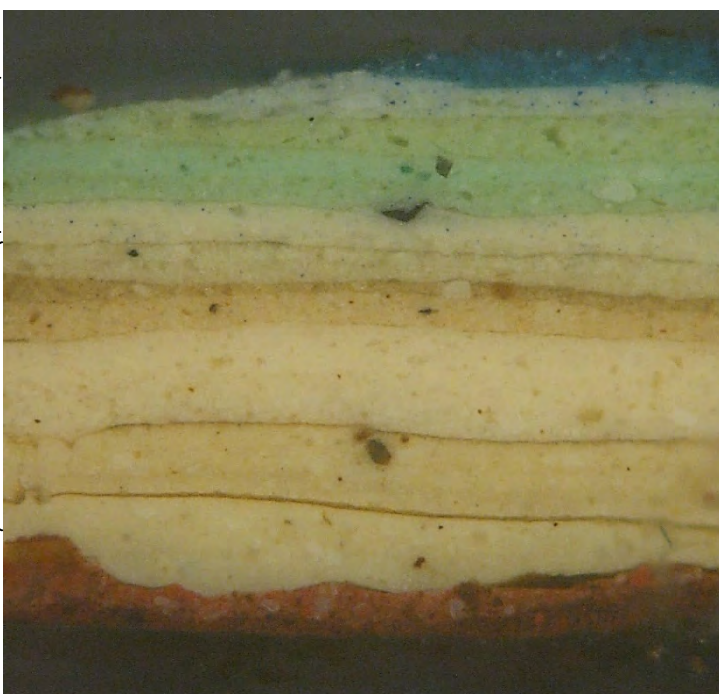
SAMPLE A4

Room 1 ceiling beam

layers containing
C19th pigments [see p.4]

six buff or cream-
coloured house paints

the red is in two layers so
is not a primer [see next page]

- 1 Following the layer of plaster the beam was painted a reddish brown. The paint was applied in two layers: a dark brown based on pure umber, followed by a reddish brown mixed from red/brown iron oxide and a small amount of lead white [see detail p.6].
- 2-7 Six lots of cream, or buff-coloured, oil paint all based on lead white and varying amounts of iron oxide and carbon black.
- 8 A pale blue tinted with a few particles of French ultramarine blue must have been applied after 1828 [see detail p.6].
- 9-11 Three pale green schemes, two of which contain some chrome yellow
- 12-13 Two more blue schemes, the first tinted with ultramarine, the second with Prussian blue.

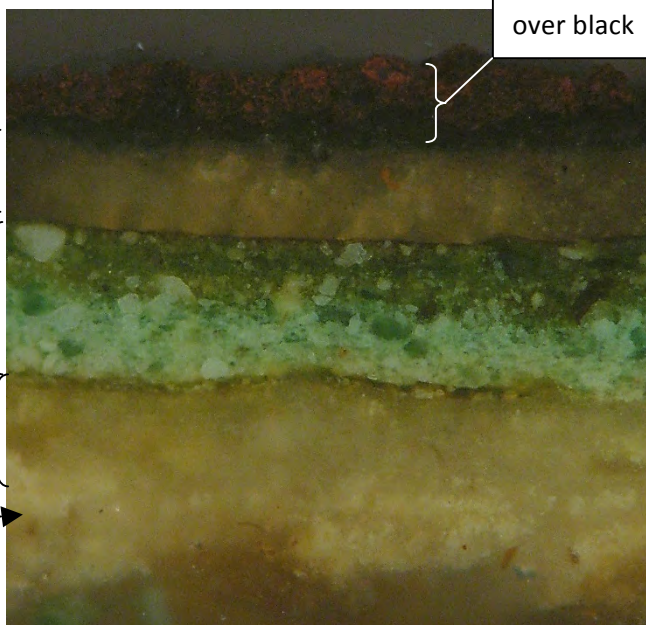
SAMPLE A5

Landing ceiling beam

skim of plaster

copper green

dirt-stained limewash

The green was followed by a coat of plaster and then the beam was painted first black and then dark brown. The brown was not the same as the red/brown used in Room 1.

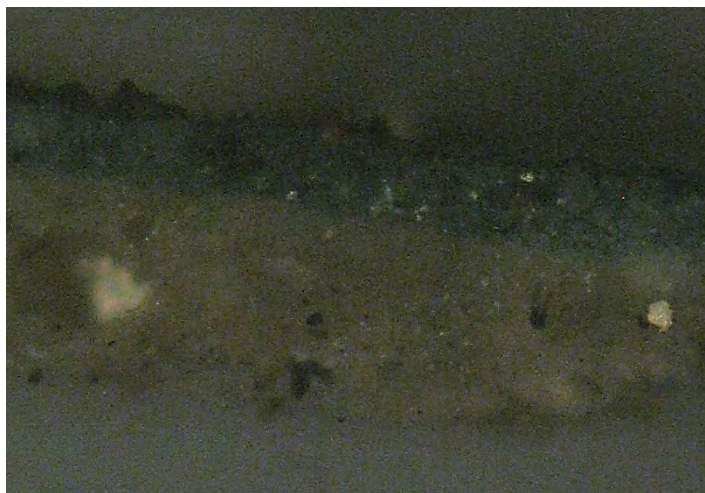
Paint dispersion of the blue in plain
polarised light.

The blue is an organic blue
and appears as a stain rather
than as particles

The blue could be indigo, but for certain identification, instrumental organic analysis would have to be carried out.

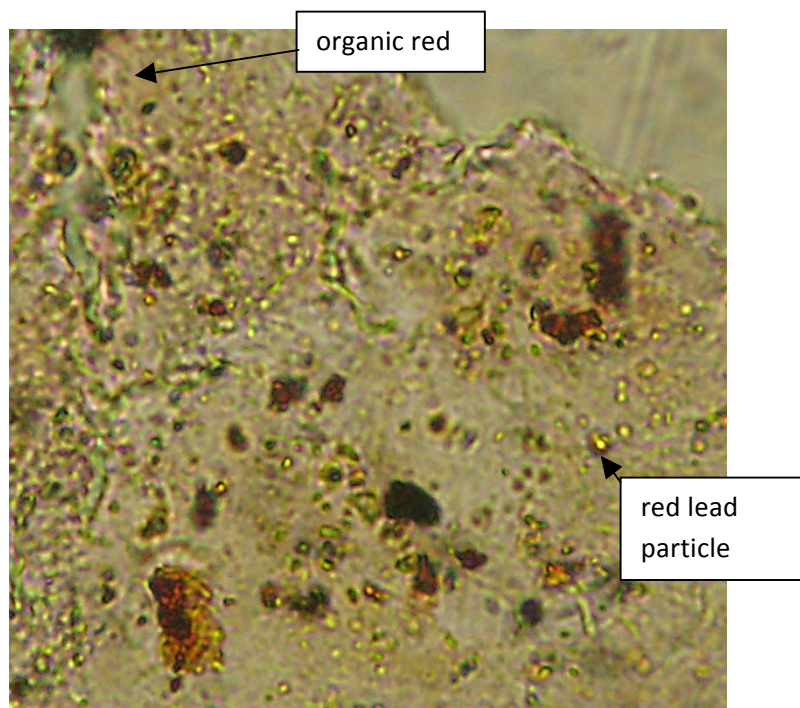
**SAMPLE N15**

Rightmost stud

A coating of dirt was present in all of them. In Sample N15 [p.9] the cross-section shows a lump of red lead caught up in the dirt layer, but the surface of the wood has no paint layer on it.

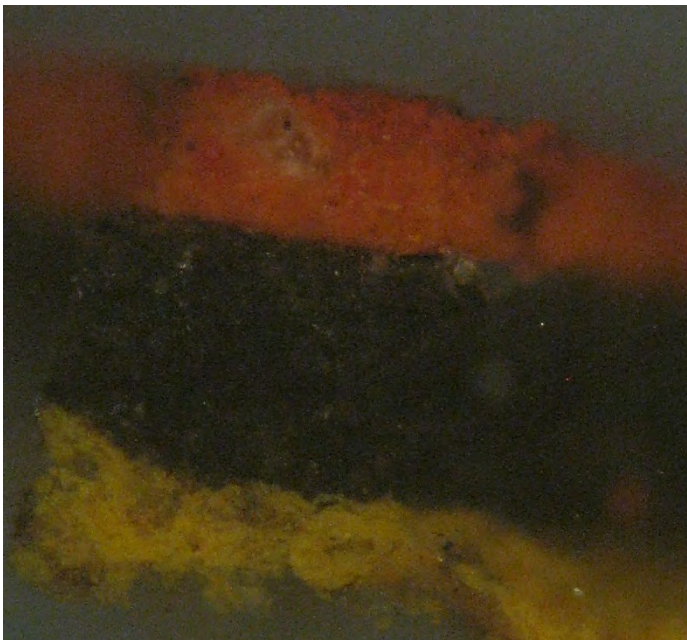
SAMPLE N18

Attic – ex situ timber

No black in this sample, and the red and yellow layers are separated by dirt-filled limewashes

In Samples N17 [p.10] and N19 [p.11] the yellow was followed by a coat of pure carbon black. In Sample N18, in place of the black the cross-section shows two coats of dirt-blackened limewash.

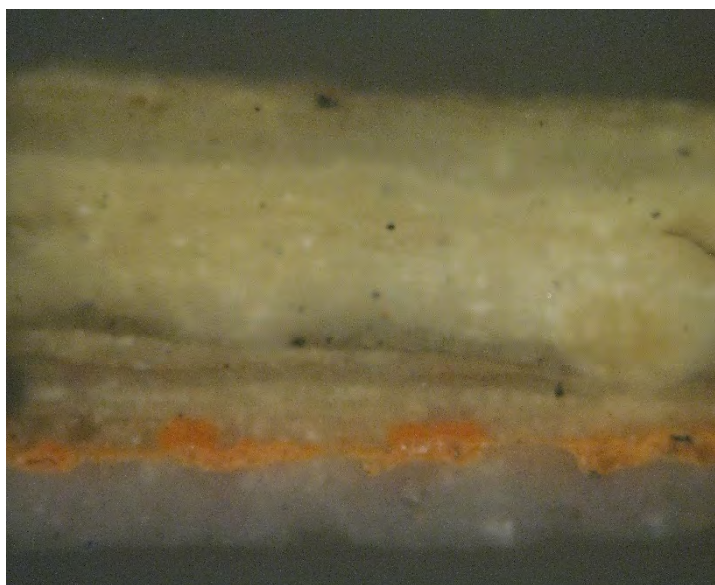
Detail of the bright red layer

The undercoat contains lead white
and could be oil paint. The top
coat is pure red iron oxide

Sample N20 [p.12]. Underneath the dark red are at least ten layers of white limewash. Between two of the earliest of those white limewashes is a thin line of bright red paint. The red was built up in two layers: a pink undercoat of lead white and red ochre, followed by a top coat of pure red ochre. The layers are unusual for house paint and the red may have been a loose paint flake from wall paper.
