37 Church Street

Part of a multi-phase house that incorporates a 16th century timber-framed frontage range aligned NW-SE extended in double pile form to the rear in the 17th century by a timber-framed range with three jettied gabled roofs running at right angles to the street. With mid 18th century remodelling a red brick façade in Flemish bond has been constructed to the street and incorporating No. 36.

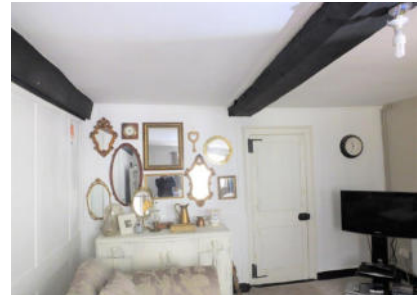
The frontage range at ground floor contains a large section transverse beam with chamfers and run-out stops to the rear. A new section of timber has been scarfed in close to the front wall. The party wall has a section of the axial beam visible above 18th century panelling. An 18th century two panel door on L hinges gives access to a cupboard that connects to the room in the rear range. The SE room is heated by an inserted stack that intrudes into the hall. There are a range of doors along the NW side of the hall. To the rear a boarded door on strap hinges give access to

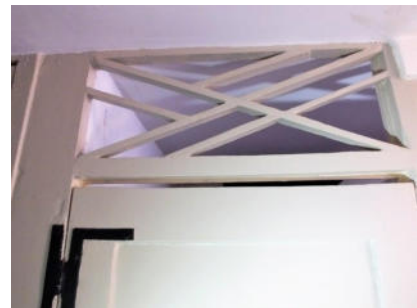
the cellar via winder brick steps to a barrel vaulted brick cellar with brick floor. A four panel door accesses the winder stairs to the first floor and a small room at the front with a vertical sliding sash window and ventilated over door panel in Chinoiserie style has an 18th century two panel door on L-hinges.

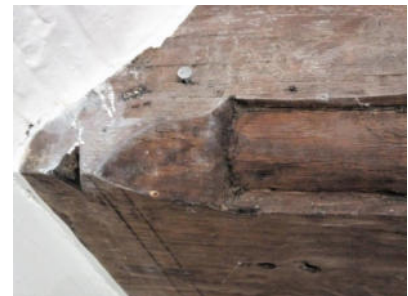
The timber-framed rear range is of high quality with quadrant moulded stepped chamfers, lamb's tongue stops with the typical 17th century notch to the end. A section of 18th century panelling and a corner cupboard survive adjacent to the central stack.

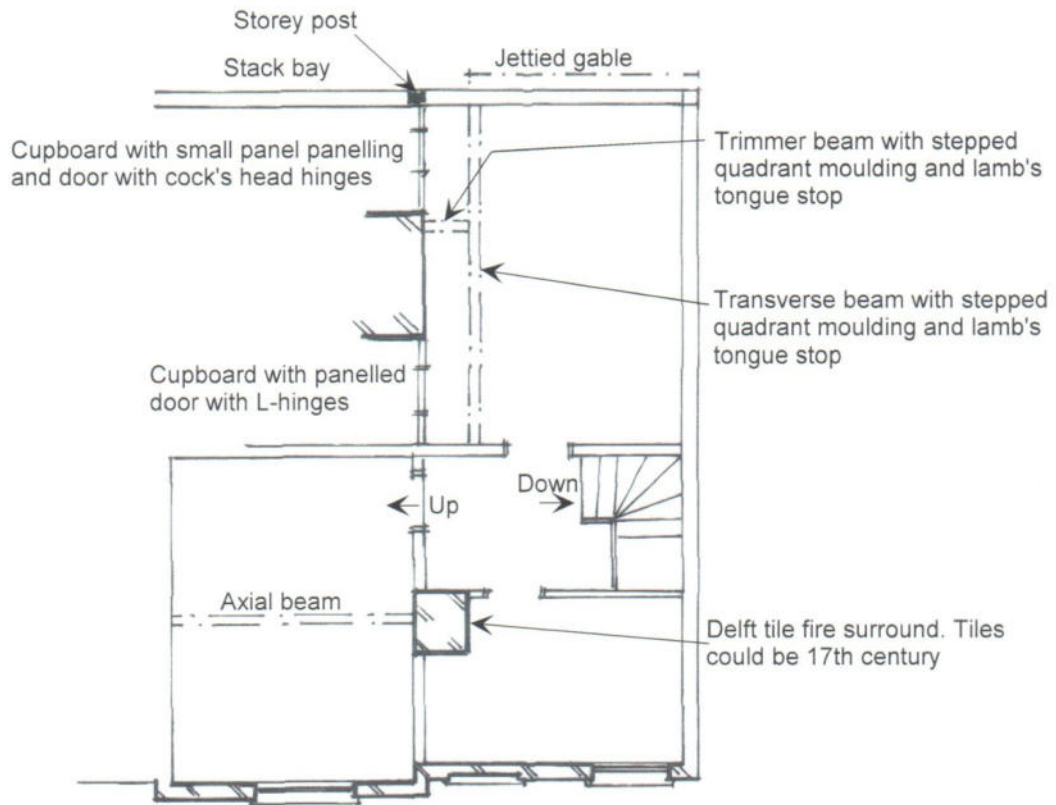
FIRST FLOOR

An axial beam is visible in the SE room at first floor level of the frontage range and the NE room has a small fireplace to the inserted stack with early Delft tile surround. The rear room of the 17th century range has a transverse beam with quadrant moulded stepped chamfers and lamb's

tongue stops. A trimmer beam running axially towards the stack is also chamfered and stopped in identical fashion. To the west of the stack is a section of 17th century panelling with panelled door on cock's head hinges that gives access to a cupboard or former closet. The cupboard to the east of the stack has an 18th century boarded door on L hinges.
