13 St Austin's Lane, Harwich, Essex.

13/14 St Austin's Lane, Harwich, Essex.
 TM 26024 32760
 List ref: 1298463

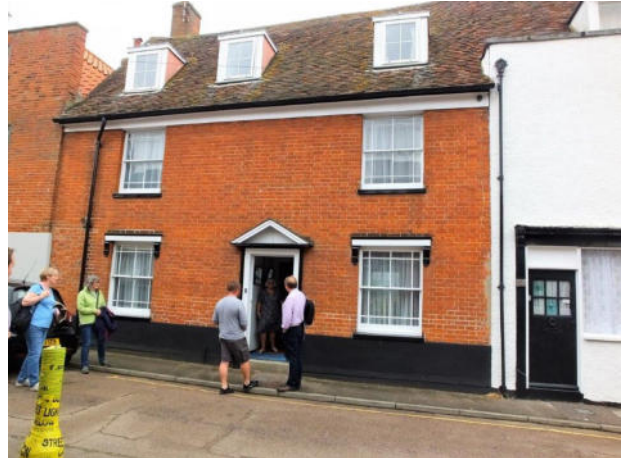
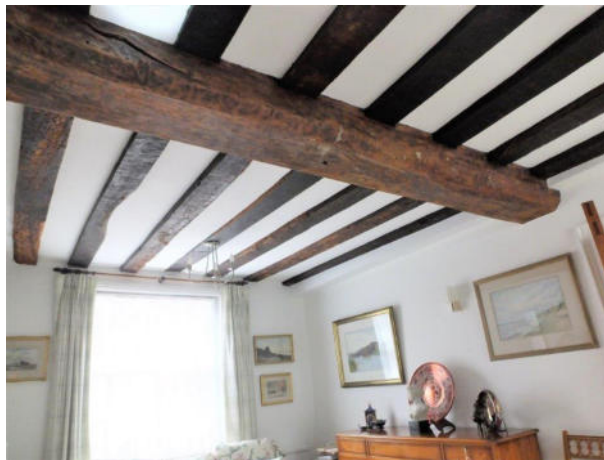
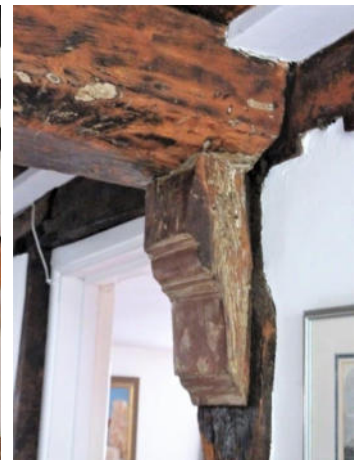
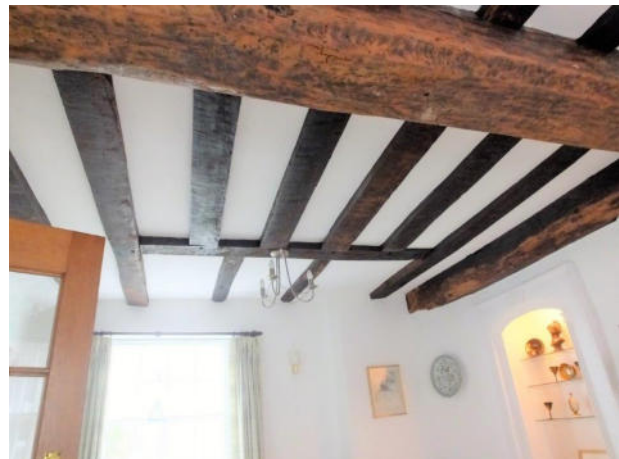
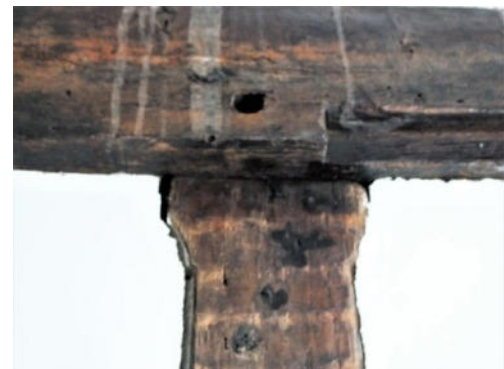
The chamfers are continuous and not finished with stops and is supported against the central storey post with a moulded corbel bracket retaining evidence of an earlier paint scheme. The unstopped chamfer and corbel bracket pose the question was the floor inserted or reused? The joist joints are no longer visible but according to the list description have soffit shoulders with upper haunching. Could this mean shouldered soffit tenons with diminished haunch? Some scribed carpenter's assembly marks are visible in the present hallway and a framed stair trap is positioned against the rear wall in the NE corner. The central frame is now infilled with reused chamfered floor joists with scribed carpenter's marks. Against the rear wall to the soffit of the west face of the mid rail is a rebate for a former

doorway. Original peg holes appear to suggest possible openings either side of the central storey post. At some point the east section connected with 14 St Austin's Lane as evidenced by a doorway in the rear bay, contemporary to the crosswing.

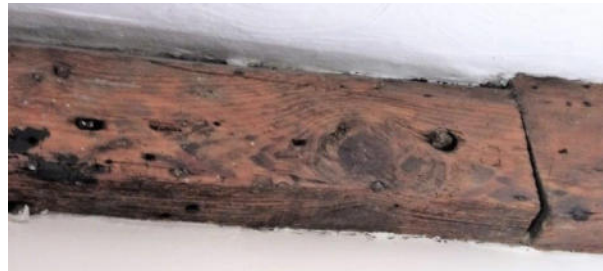
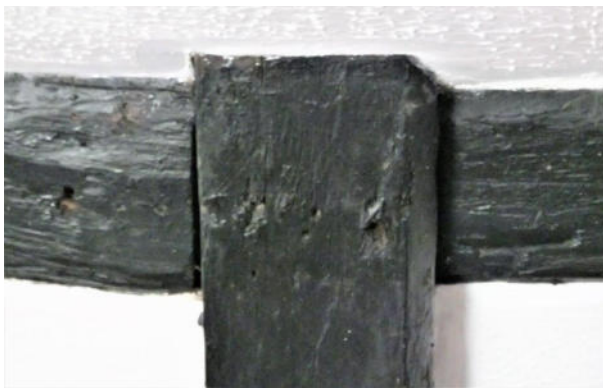
At first floor level the top of the central oak storey post is visible. Other timber visible is the softwood wall plate with face halved scarf and softwood axial beam with pegged joints for the attic floor joists. The roof is divided into

three bays by two principal rafters with framed side purlins. It is all painted black and assumed to be softwood.
