Samuel Pepys Restaurant, 31 Church Street, Harwich.

A 16th century timber-framed building of two phases aligned NW-SE with late 18th century brick front façade in Flemish bond.

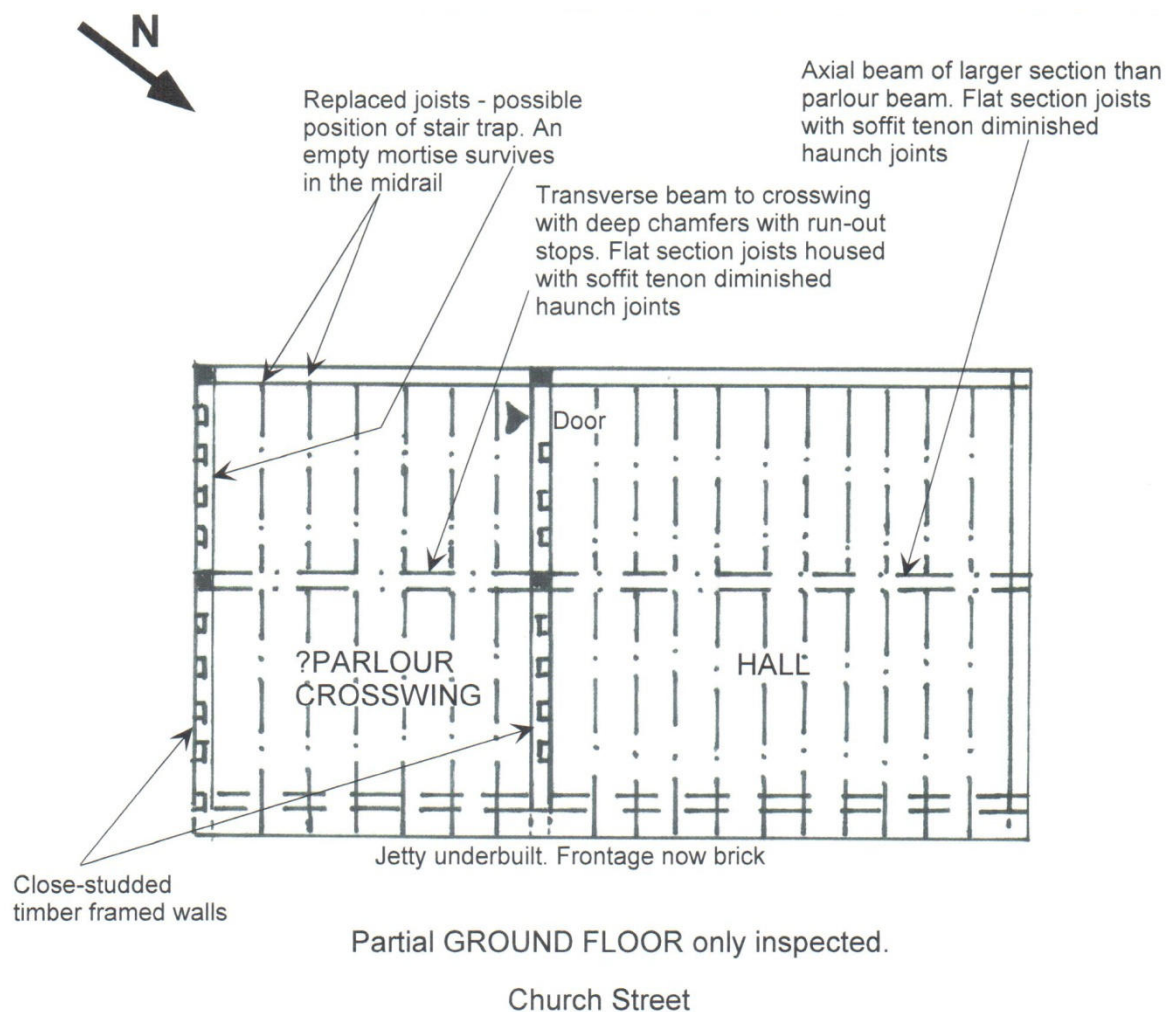
Floor joists of cross wing to street. Jetty plate would have been above the light. Second picture shows remains of mortise for a jetty bracket and mainly destroyed dovetail housing for the jetty plate.
