66 Church Street, Harwich.

A 16th century 2 storey timber-framed house aligned NW-SE with later rear range, attic and brick front façade in Flemish bond with vertical sliding sashes 8:8 and 19th century doorcase and door.

Elphin & Brenda Watkin, October 2019

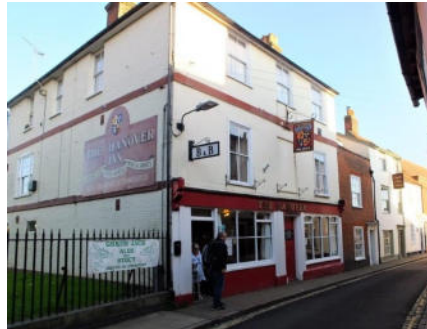
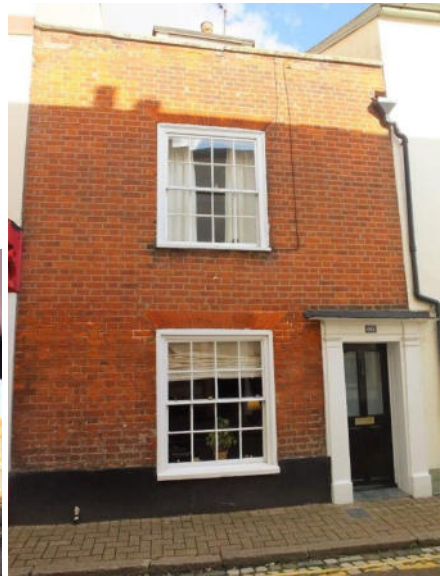
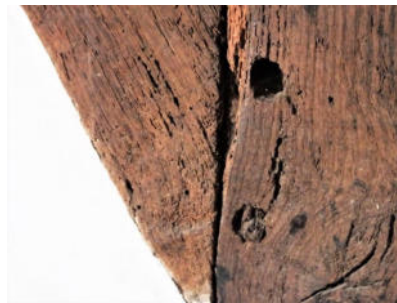
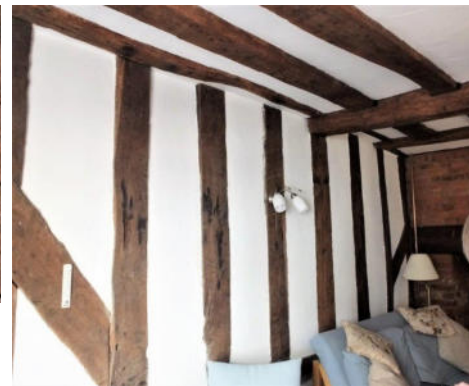
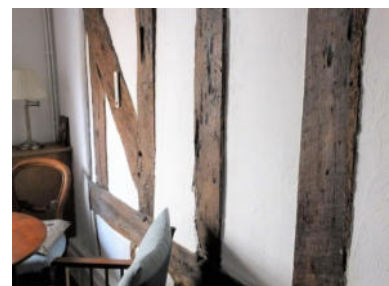
ground floor level has wide double pegged trenched braces of Colchester style. These now exhibit a number of taper burns.

framing spans an axial beam. This has deep chamfers with run-out stops and flat section joists housed with barefaced soffit tenons. A trimmer to the front of the north jamb of the hearth could mark the position of the original stair trap. The existing cooking hearth has been rebuilt and possibly widened so covering the evidence to confirm the original position of the stairs which now take the form of a straight flight behind the stack.

At first floor level the original roof level has been raised. The wall of The Hanover is visible with midrail showing above floor level and is of close studded style without braces. The SE timber-framed wall has trenched tension braces falling from front and rear jowled storey posts to mid rail. In a cupboard to the SE of the stack is a scarf joint of semi-splayed edge halved form with face pegs.
